Excavation on the Taiye Pond Site in the Daming Palace of Tang Chang'an City

Joint Sino-Japanese Archaeological Team of the Institute of Archaeology, CASS
and
Nara Cultural Properties Research Institute

Key words: Tang Chang'an city Daming Palace Taiye Pond site covered walkway
inflow channel

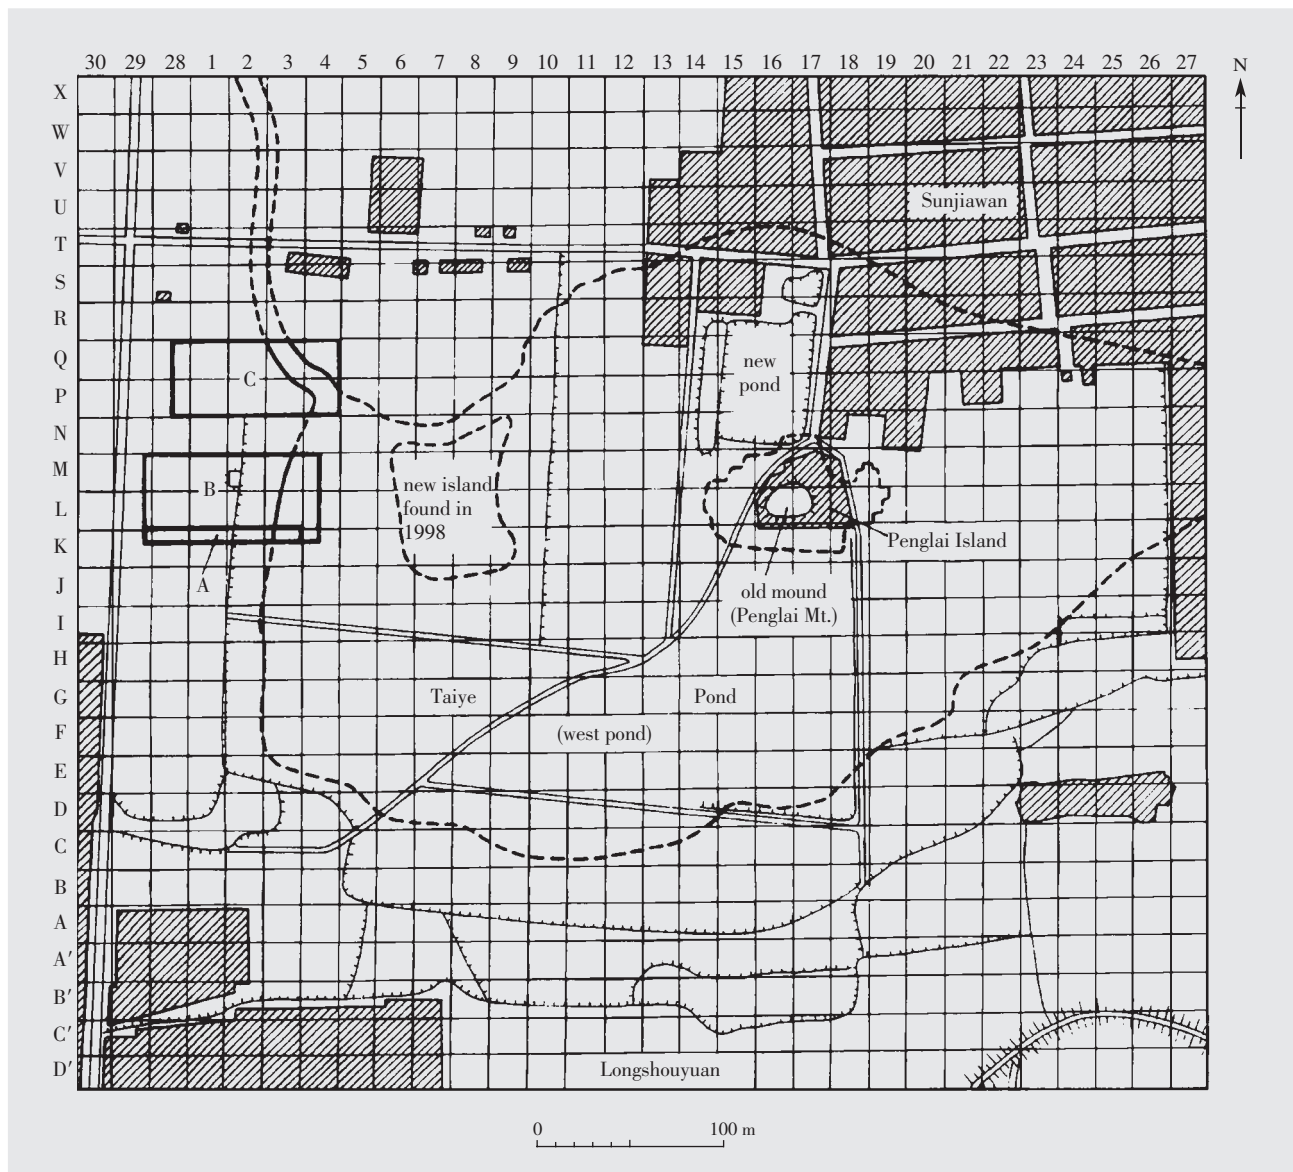
Fig. 2 Location of the excavated area in 2001–2002 of the Taiye Pond site

A. test excavated area in the autumn of 2001 B. excavated area in the spring of 2002 C. excavated area in the autumn of 2002

A five-year plan of large-scale excavation and research at the Taiye site began to be carried out in the latter part of 2001. From the beginning to December of 2002, the Joint Sino-Japanese Archeological Team carried out three major excavations at the middle and the northwestern parts of the west bank, excavating an area of 8,400 sq m (Fig. 2). The excavations helped to understand the structures on the bank, remains of nearby roads and ar-

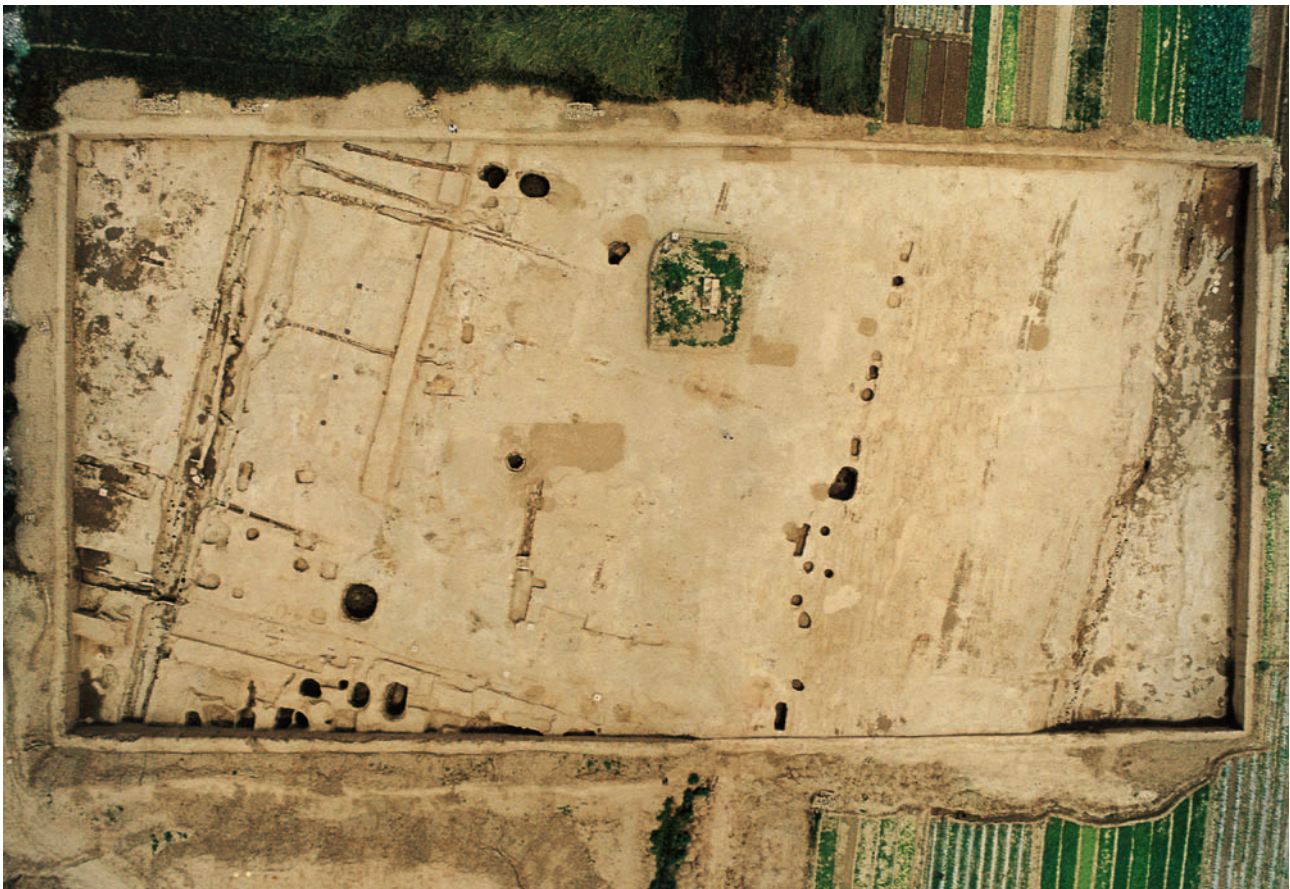
Fig. 4 The excavated area of the Taiye Pond site in the autumn of 2001 and the spring of 2002

Cultural remains exposed by the excavations include the bottom and the banks of the pond; roads on the banks of the pond, trash pits, architectural remains, drains, and the channel that carried water into the pond (inflow channel) along with attached structures (Figs. 3–6).

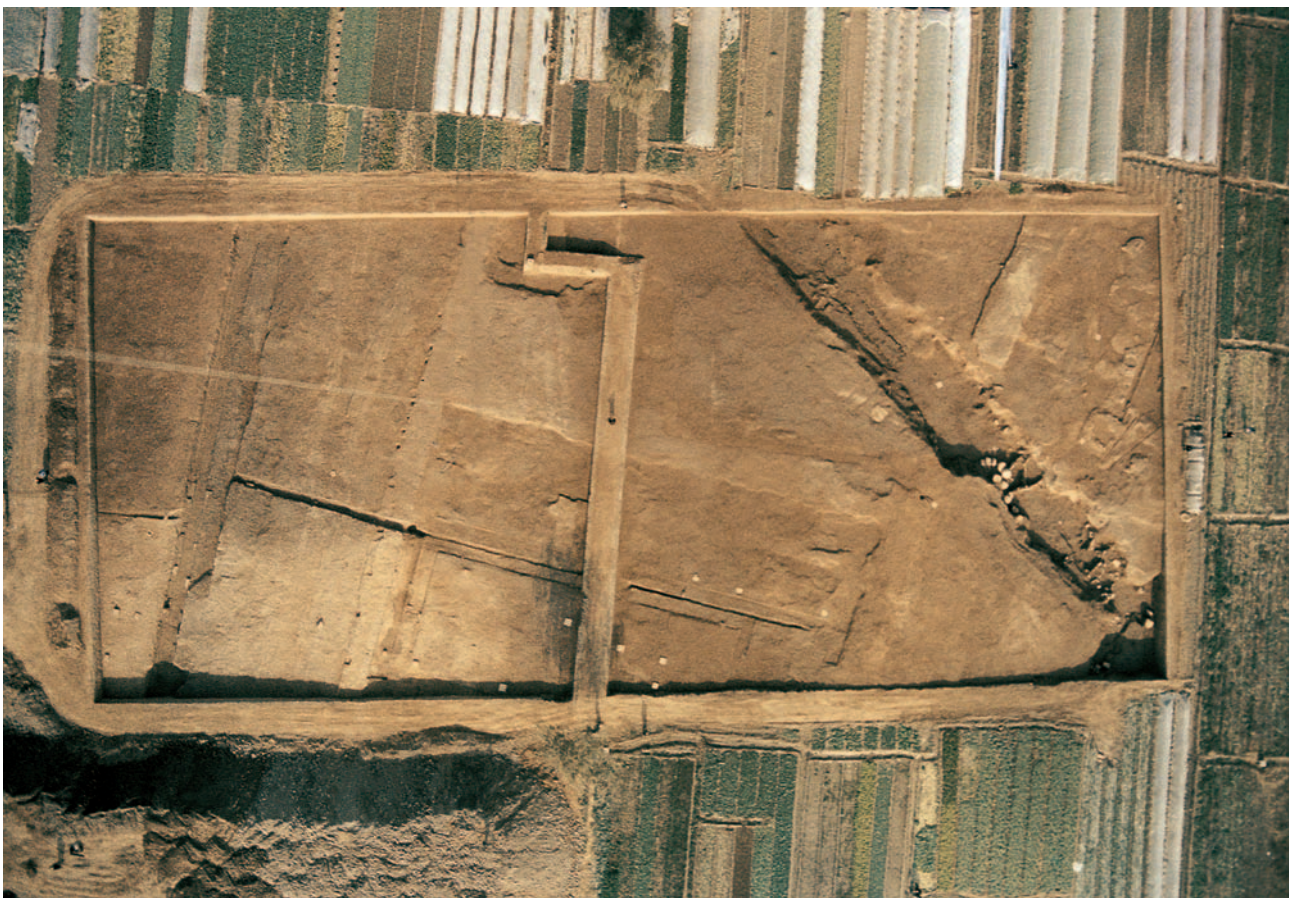
Fig. 6 The excavated area of the Taiye Pond site in the autumn of 2002

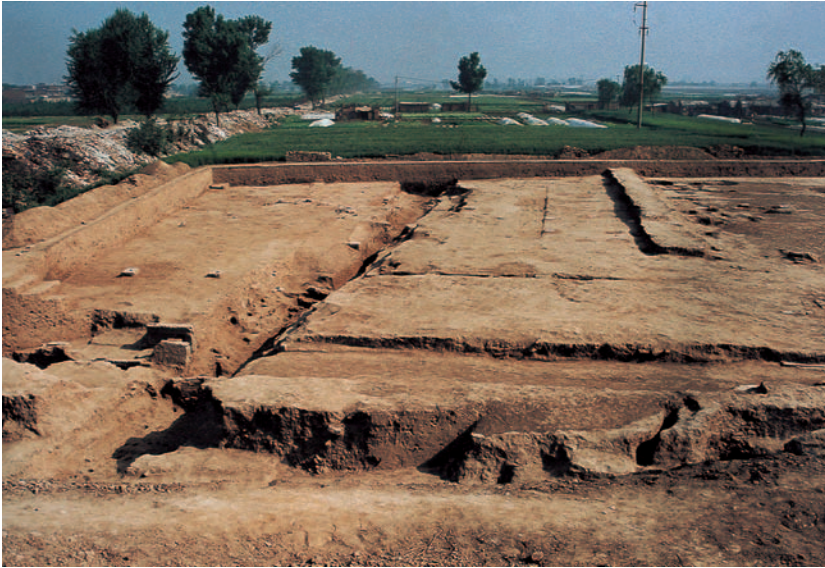
Fig. 7 Covered walkway F4 (photo taken from south to north)

Early houses: two of the houses (F4, F5) have been identified as early buildings. The remains of F4 include 7 square stone column bases, several pits and holes for columns, and on the east side a retaining wall of stamped earth (Fig. 7). The distance between the stone column bases is different: from east to west the distance is 4.05 m, while from north to south the distance is 3.7 m. From this we can learn the width and depth of the rooms of the house. The remaining stamped earth wall is 0.05–0.7 m high and 2–2.5 m wide at the base. The remains indicate that house F4 opens to the west, had a single room. The roof of the house was single-sloped, and covered a linear veranda running northeast to southwest.

It is also worth to pointing out that F4 and F5 are probably the remains of the covered walkways built in the 12th year of Yuanhe 元和 reign period (817) by Emperor Xianzong 宪宗. According to *Jiu Tangshu* 旧唐书 (Old History of the Tang), in the 12th year of the Yuanhe reign period, Emperor Xianzong built covered walkways with 400 rooms along the Taiye Pond.

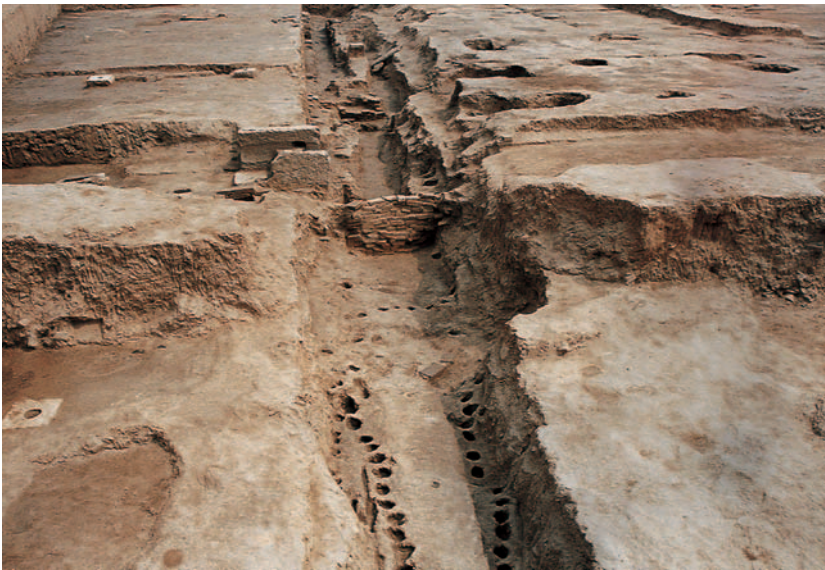
Fig. 8 Drainage channel G1 (photo taken from south to north)

The main channel (G1) is located in the western section of the excavated area, running northeast to southwest. The known measurements of the channel

are 98 m long and 1.2–1.5 m wide. From the bottom of the channel to the top is 0.76–1.18 m (Fig. 8). The northern part of the bottom of the channel still has bricks along the two side walls, with 0.85 m between the walls. The side wall on the west is still vertical, but on the east the wall is sloped due to damage. No bricks are preserved on the flat bottom of the channel. On the southern part of the channel, we found post holes along the side walls; the posts were probably used for supporting the two walls. It is also possible that once a bridge or culvert was built there. We found also four brick walls crossing the southern part of the channel; it is difficult to understand the functions of these walls. From the surface level of the channel, water was drained from north to

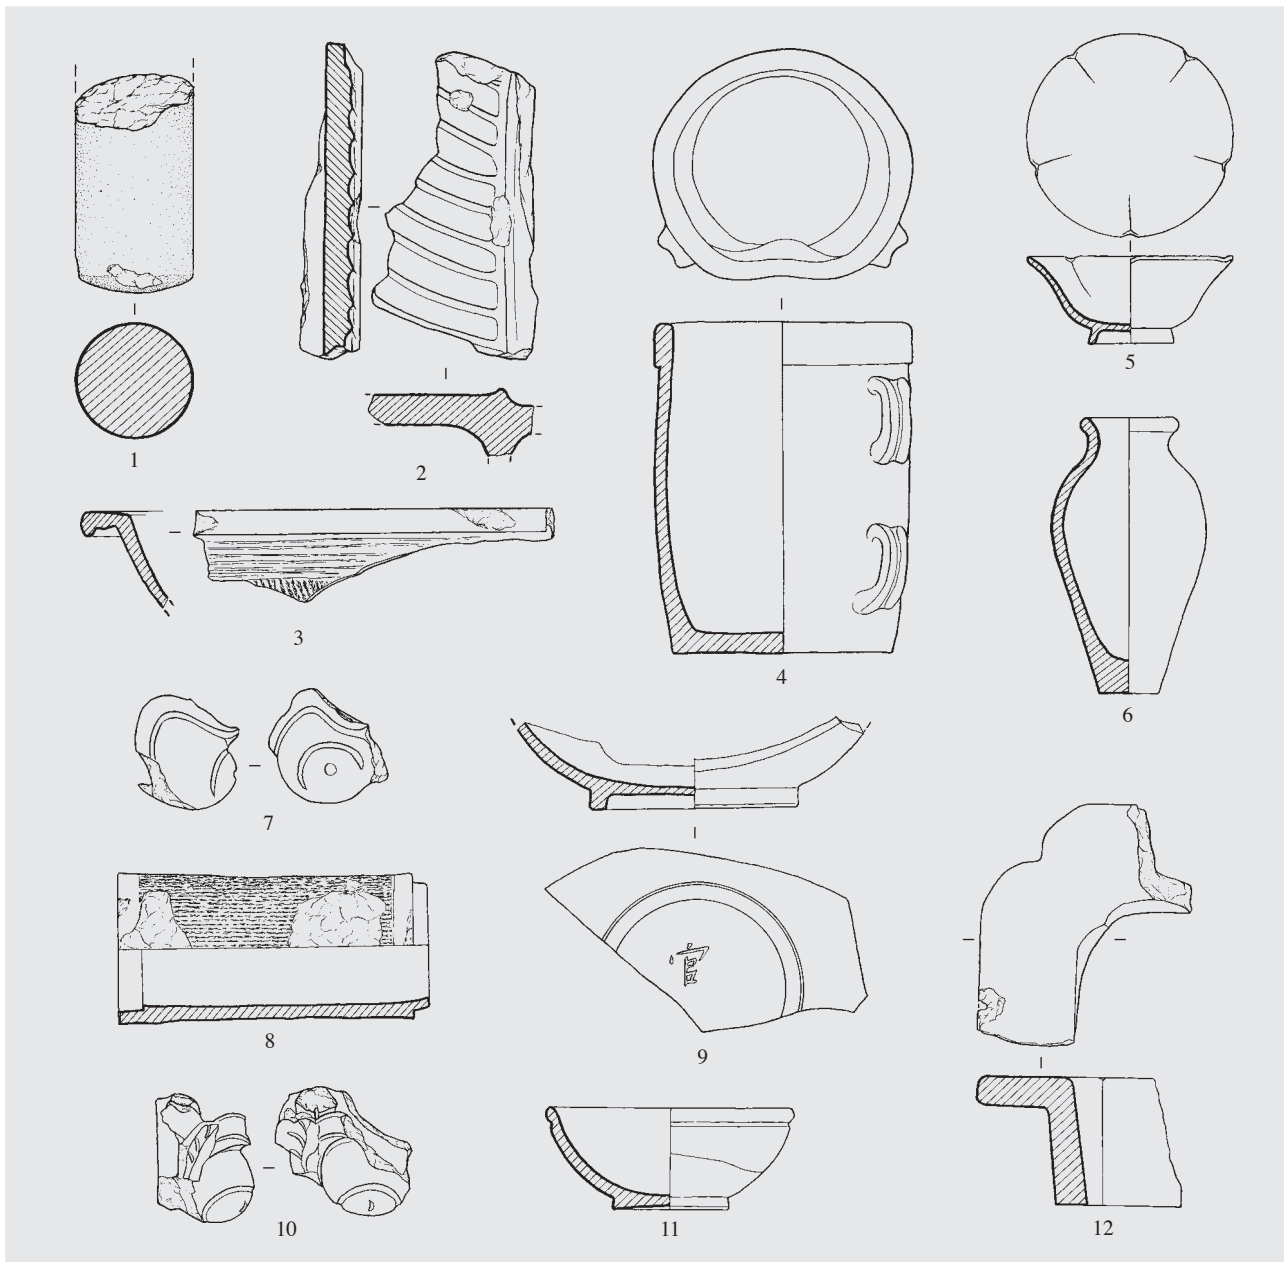
Fig. 9 Unearthed objects

1. stone pillar (T28④:46)
2. ceramic ridgeline ornament (T3Q4:26)
3. ceramic *weng* urn (T2M④:11)
4. ceramic water container (T4L④:29)
5. porcelain type C bowl (T29L④:14)
6. ceramic *guan* jar (T4L④:26)
- 7, 10. ceramic animal's eye (T3Q④:28, 29)
8. ceramic pipe (T28M④:29)
9. porcelain bottom of bowl (T28L④:27)
11. porcelain type A bowl (T1M④:93)
12. stone flowerpot (T28K ④:52) (scales: 3, 8, 1/10; 9, 2/5; the rest 1/5)

Cultural artifacts found in the late Tang stratum include bricks, tiles, and objects made of ceramic, stone, iron, and bronze. Coins were also found (Figs. 9 and 10).

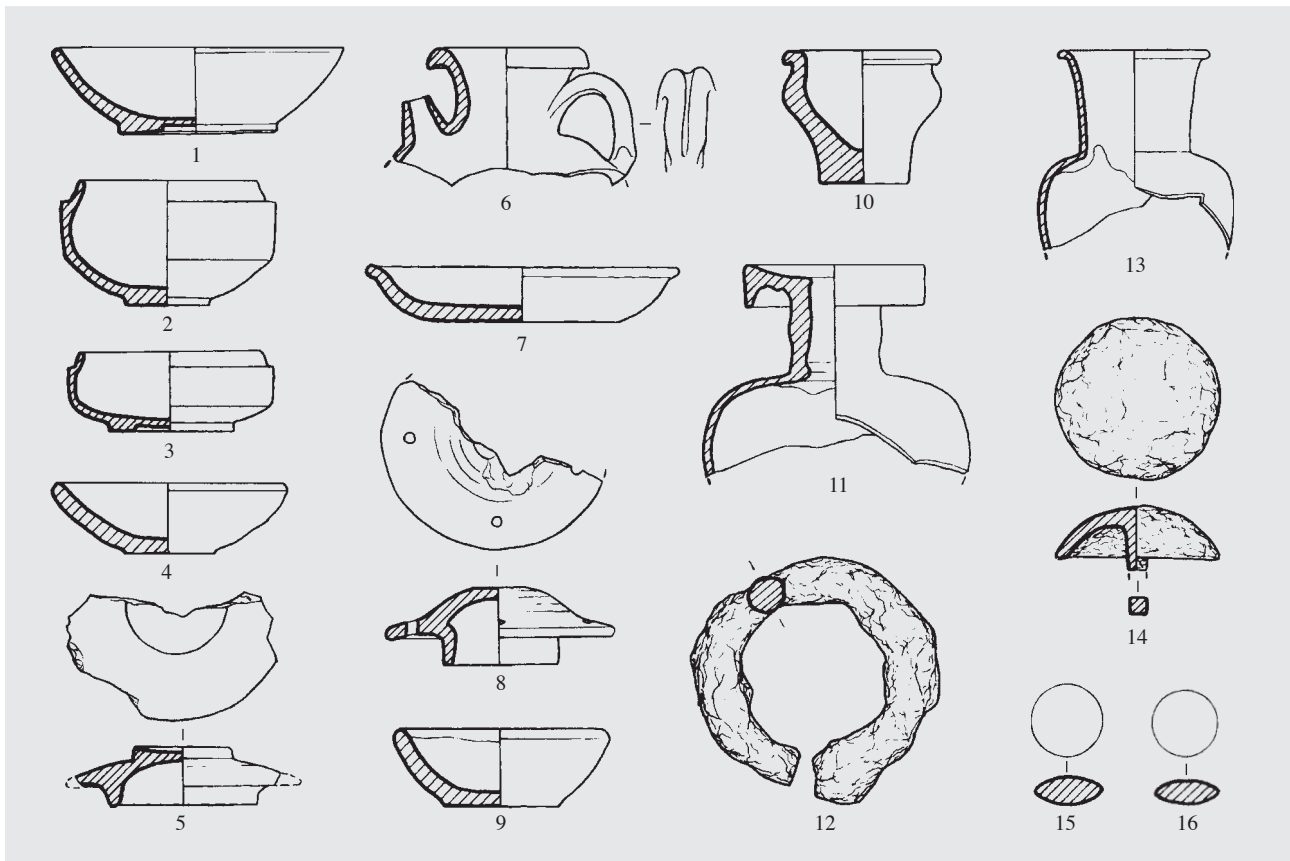
Fig. 10 Unearthed objects

1. porcelain type B bowl (T3K ④:12) 2, 3. porcelain round containers (T28M ④:36, T1M ④:98) 4, 9. glazed ceramic cups (T4L ④:27, T1L ④:71) 5, 8. glazed ceramic lids (T3Q ④:33, 32) 6. porcelain pitcher (T28K ④:88) 7. porcelain plate (T1L ④:78) 10. ceramic *guan* jar (T1L ④:60) 11, 13. ceramic tri-color jugs (T1L ④:94, 93) 12. iron ring (T4Q ④:51) 15, 16. stone go (T28M ④:51, 61) (scales: 2, 15, 16. c. 1/2; the rest c. 1/4)

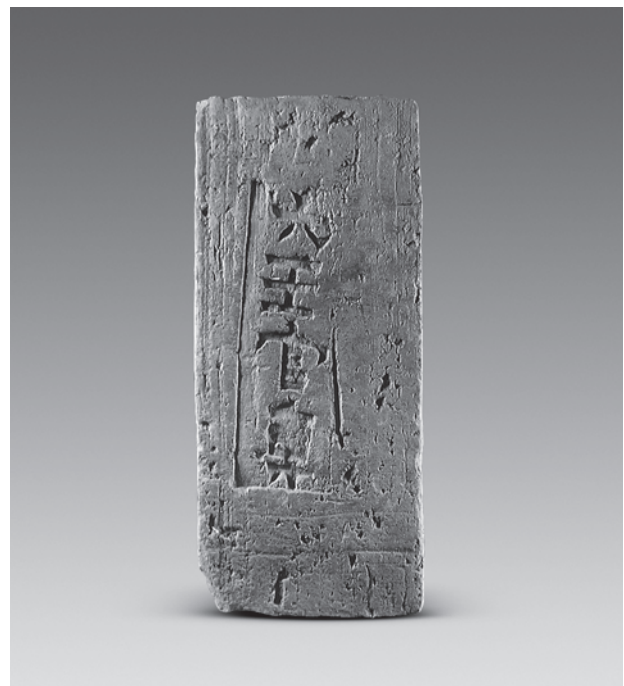
Fig. 11 Rectangular shaped brick with inscriptions (T4Q ④:17)

scriptions of craftsmen's names, the date when the bricks were manufactured, and names of the kilns. For example “*Jiang Zhao Ji* 匠赵吉”(Craftsman Zhao Ji), “*Zuo ce ren wu* 左策壬午”(Zuoce made this in the Renwu year), “*Liu wang guan zhuan* 六王官砖”(brick made by official kiln of Liuwang) (Fig. 11), and “*Shi yao* 使窑”(Shi kiln). The dominant decoration of the square bricks is lotus flowers; the rest are decorated with divine animals and grapevines, four leaves, vines and flowers (Figs. 12–15), round flowers, and geometric patterns. The flat tiles are yellow glazed or unglazed; some of them are specially dyed, so that their surfaces are shiny and black. Some flat tiles bear the prints of craftsmen's and kiln names. For example “*Jiang wang gong yue* 匠王公约” (Craftsman Wang Gongyue), or “*Tian ba an men guan wa* 天八安门官瓦”(roof tile made by the official kiln of Anmen in the 8th year of Tianbao). Some of the tubular tiles are made of tri-color ceramic. Most of the eaves tiles are decorated with lotus flowers; only few have animal heads (Figs. 16–19). The ridgeline ornaments are mostly in the shape of a bird's tail.

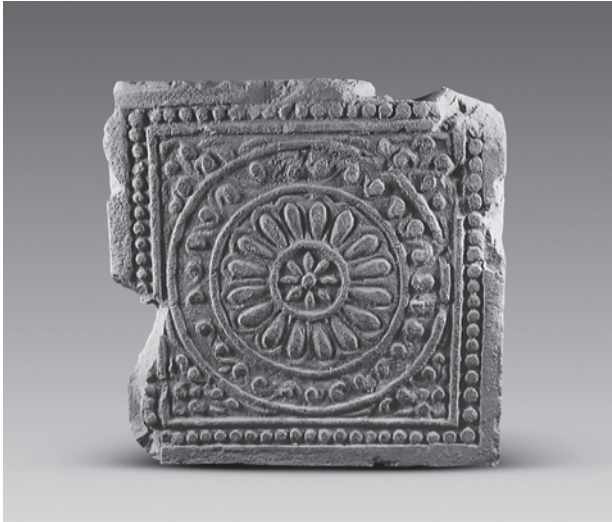
Fig. 12 Type BII square brick with lotus pattern (TIM ④:31)

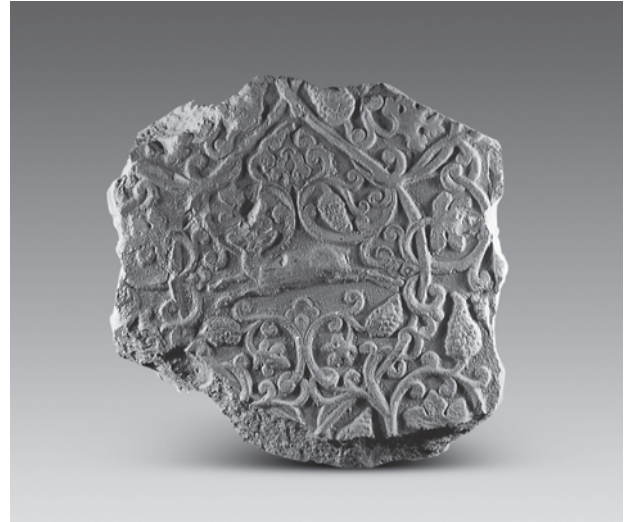
Fig. 13 Square brick with divine animals and grapevine pattern (T29L ④:5)

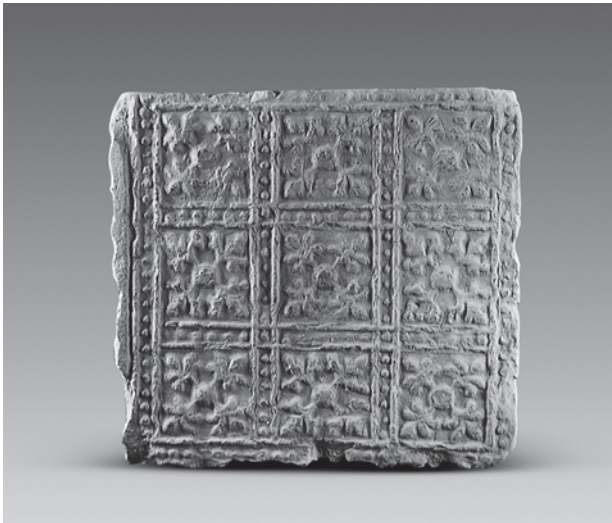
Fig. 14 Square brick with four leaves pattern (T4Q ④:3)

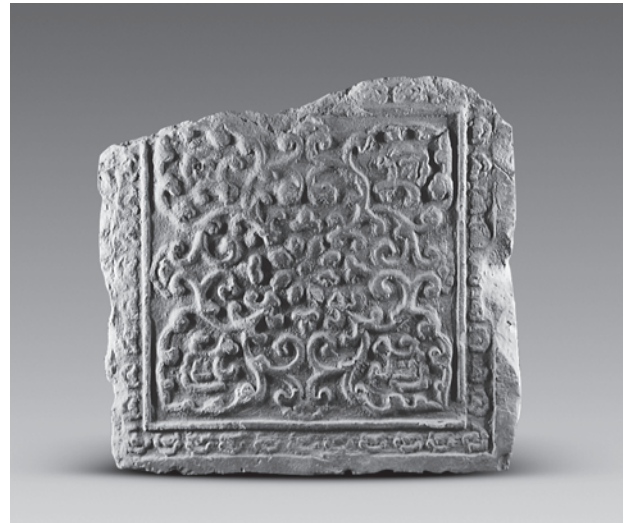
Fig. 15 Square brick with vine pattern (T4Q ④:1)
