# Excavation Report on the Dingding Gate

Tang Luoyang City Archaeological Team, the Institute of Archaeology, CASS  
and  
Luoyang Municipal Archaeological Team

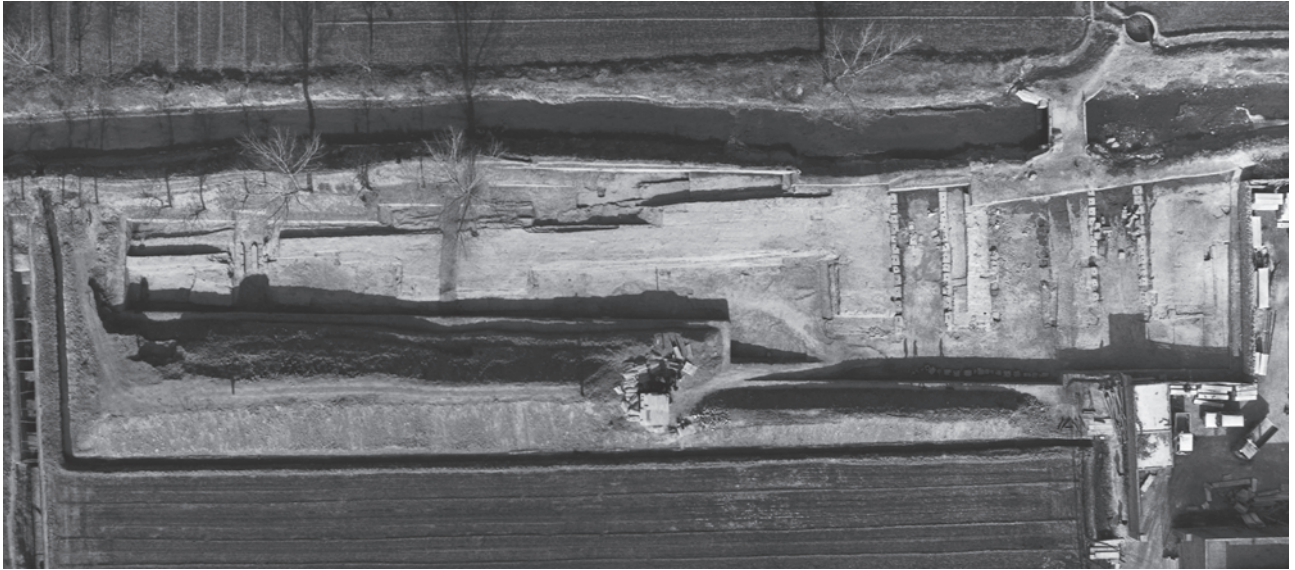
Fig. 3 Panorama of the Dingding Gate site in the middle Tang period

The gate site was constructed with three entranceways. The archaeological remains include traces of pier platforms, entranceways, partition walls, side corridors, ramps, watchtowers, and culverts. The archaeologists could not excavate the north and east sides of the site because of constraints due to recent construction (Figs. 2 and 3).

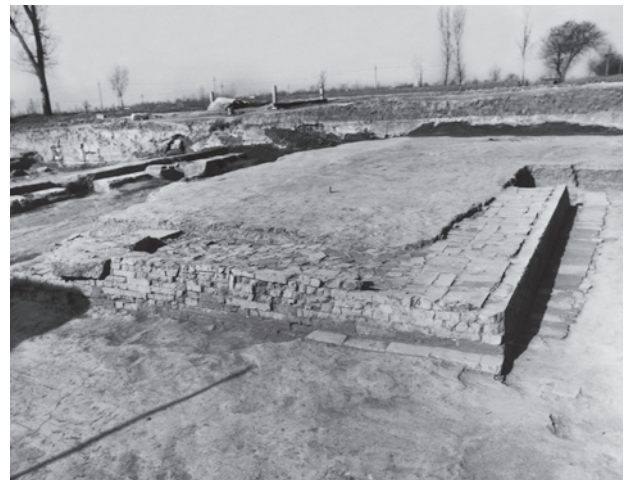
Fig. 4 Face bricks of the southeastern part of the pier platform (photo from southeast to northwest)

The foundations are 2.5 m deep and the remains of the platforms on top are 1.05 m high. On the eastern side of the entranceway, the platform is 7.98 m wide from east to west and 15.8 m long from north to south. On the western side of the entranceway, the platform is 7.98 m wide from east to west, and 21.04 m long from north to south. The platforms were faced with bricks, but these remains only on the southern and eastern edges of both platforms (Fig. 4).

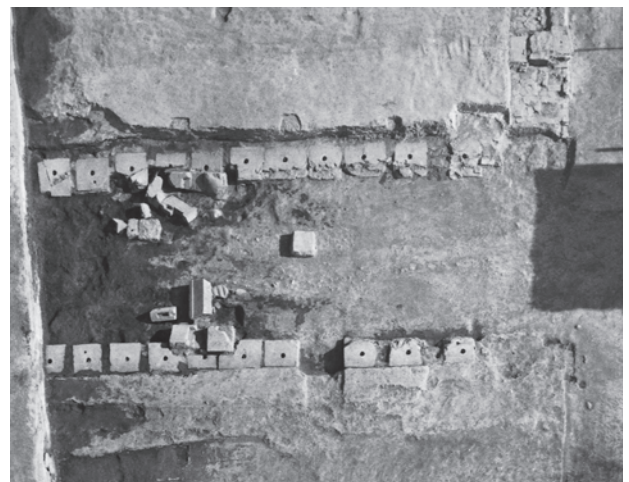
Fig. 5 East ramp

*menzhenshi*, literally gate foundation stones). The support stones are located beneath the walls on the two sides of the entranceway, lined up facing each other to the east and west. On the surfaces of the support stones are round holes intended to hold beams. Beneath the support stones, inside the rammed earth, are the lining stones, flat on the surface and roughly square in shape. The support stones are not joined together; spaces are left between them. The spaces between the stones at the northern and southern ends of each row are wider than those at the center. Between the support stones, the wall is made of bricks. On the brick walls are the remains of a surface coating of white plaster with red paint. The gate-foundation stones had been moved from their original positions and broken. On the surface of the foundation stones are holes to hold the gate sockets in which the gate-pivots turned. Each foundation stone was also incised with grooves intended to hold slabs to further support the two sides of the gate (立颊石 *lijashi*, literally stone for standing up cheeks). The archaeologists discovered two slabs with rectangular grooves for supporting the door frame. The road inside the entranceway had traces of wheel ruts. The top layer of the road was all covered with silt. Probably at some point before the middle Tang period, the Dingding Gate was destroyed by flooding (Fig. 5).

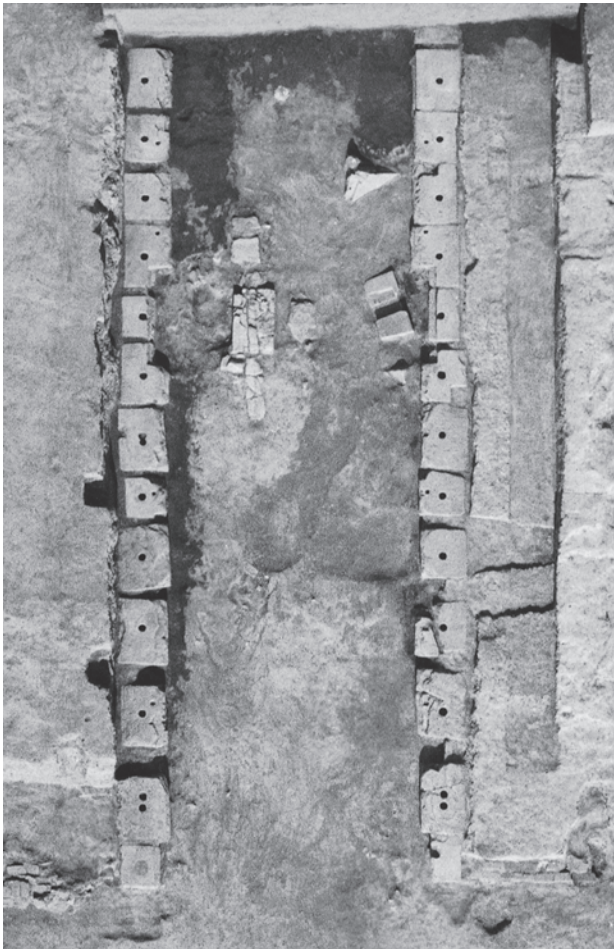
Fig. 6 West entranceway

The western entranceway was rather well preserved. The support stone foundations were complete, with fourteen square support stones under the western wall and fifteen beneath the eastern wall. The alignment was identical to that of the eastern entranceway. On top of the support stones are lines of indentations intended to hold stanchions (support beams). They still retain square marks presumably left by square-shaped stanchions. It appears that the stanchions were half inside the walls and half exposed. Because the last support stones on each end of the corridor have two indentations, it is assumed that they each held two stanchions. On the south and north ends of the entranceway (the northern end of the western wall was destroyed) the archaeologists found stones that acted as doorstops and indentations for the stones. The surface of the corridor consists of a lower

layer of cobblestone covered by an upper layer of dirt (Fig. 6).

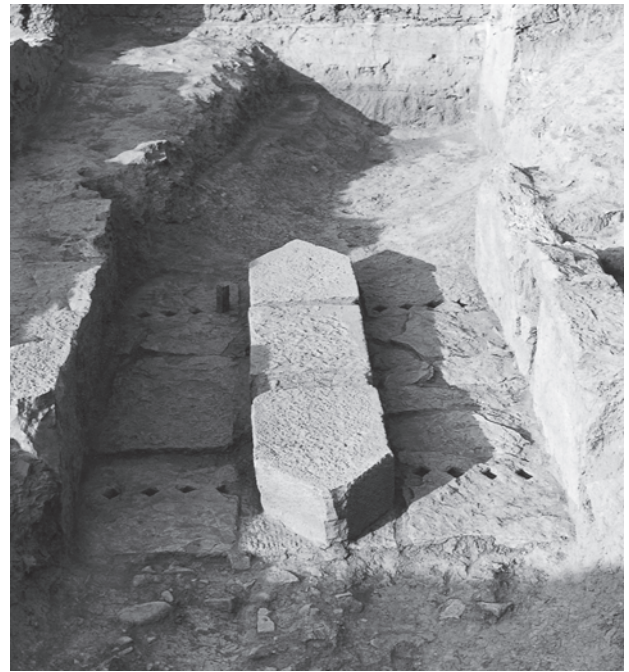
Fig. 7 Culvert to the west side of the west entranceway

(7) Culverts: both the east and west culverts are located outside the watchtowers. The west culvert is constructed of gray granite 14.9 m west of the west tower. The culvert runs perpendicularly under the city wall. It is 3.1 m long from north to south and 2.3 m wide from east to west. The archaeologists discovered a stone switch for directing waterflow (分水石 *fenshuishi*, literally a stone that divides water) in the middle of the

culvert that allowed the water to alternate between two different channels. The stone switch originally consisted of three pieces of stone of which only the bottom layer remains. The two channels are each 0.83 m wide. Both ends of the channels contain stones that acted as foundations for grills. In one of the holes drilled in the foundation stones the archaeologists found remnants of an iron grill (Fig. 7).

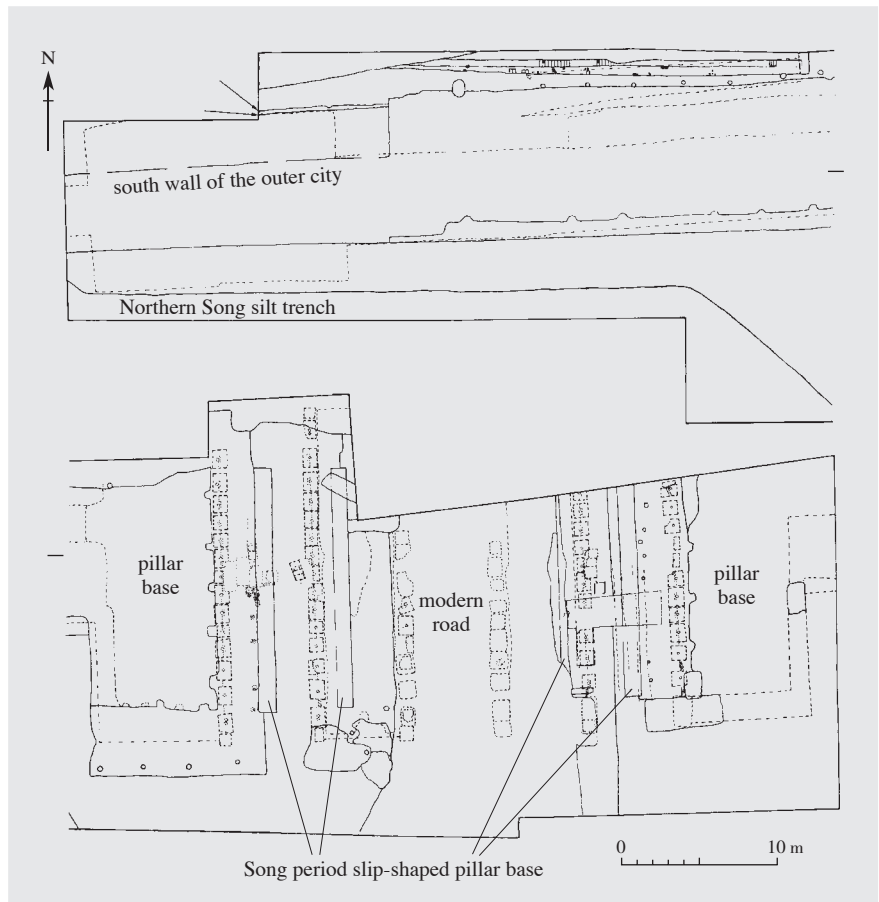
Fig. 10 Plan of the Dingding Gate site in the Northern Song dynasty (upper: west section; lower: east section)

Although people continued to use the form of the three-entranceway gate during this period, the east and west entranceways moved inward and became narrower. The remains include pier platforms, doorways, and ramps (Fig. 10).

(1) Pier platforms: the rectangular-shaped pier platforms are 44.5 m long from east to west and 23.3 m wide from north to south. The earlier platform foundations were continuously used, but the retaining walls were reinforced. The northern side was extended 3.7 m. The southern side was extended 4.3 m. Stanchions were found inside the new rammed-earth walls.

(2) Entranceways: the middle entranceway is severely damaged. The archaeologists found the northern Song support-stone foundations were all moved inward such that the eastern doorway's eastern side was rebuilt in the middle of the entranceway corridor of the gate from the period before the middle Tang, and its western side was rebuilt on top of the middle Tang partition wall. The remaining foundations are 13.55 m long, 1 m wide, and 0.8 m high. The distance between the two sides is 4.9 m. The foundation contains some broken bricks and tiles. The western entranceway presents a similar situation. The remaining foundations are 15.6 m long. The eastern side is 1 m wide, and the western side is 1.2 m wide. Both are 1.05 m tall. In both east and west entranceways the archaeologists discovered the remains

(3) Ramps: the ramps were straight. The west ramp had been in continuous use from the earlier periods. The width of the ramp slightly increased. The excavated part of the remaining west ramp is 34 m long and 3 m wide. Repairs from this era are visible.
