Palatial Garden Pond at the Shang City in Yanshi, Henan

Second Henan Field Team, Institute of Archaeology, CASS

Key words: Shang city at Yanshi palatial garden pond

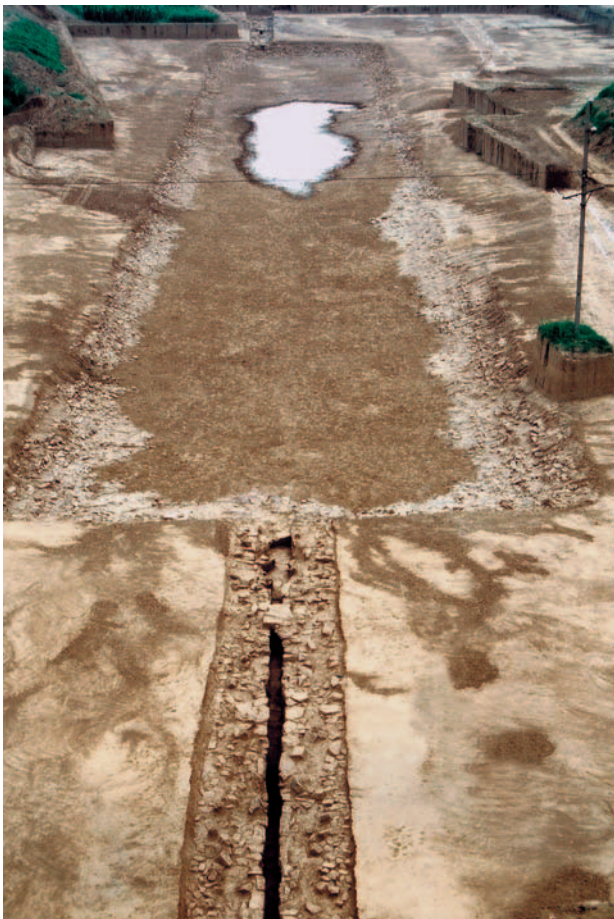
Figure 2. Palatial garden pond (photo taken from west to east)

The pond was located in the middle of the residences in the north section of the palace, 25m from the eastern palace wall and 25–7m from the north palace wall. It formed an inverted trapezoid shape oriented to 101 degrees (based on the north wall). Its basic form was that of a rectangular, dipper-shaped pit, the four walls lined with stones of varying sizes. Portions of the pit mouth had undergone varying degrees of erosion. The remaining part of the pit mouth measured 128m from east to west and approximately 19–20m from north to south. The four walls were gently sloped, and the central part of the pit bottom

The stone walls had undergone extensive degradation. The stones of the mouth portion had already completely fallen away, and the west, north, and east walls, as well as the east portion of the south wall and the majority of the remaining portions of the lower half, could barely be made out, the fallen stones having for the most part formed loose piles near the walls (Figure 2). In order to preserve the remaining portions of the stone walls, the excavation project organized the upper layers of stones that had already fallen, as well as the fallen stones of the northwest corner and the middle portion of the north wall; the project also disassembled and analyzed the eastern portion of the pond. The surviving portions of the stone wall ranged from 0.4–1m in height. Based on these figures, the pond originally measured only 127m from east to west and 17.5–18.5m from north to south, and the stone wall was 0.5m thick. The ramparts of the stone wall were comparatively complete, their four cor-

ners nearly forming right angles, and though the slope formed by the surface of the walls was generally greater than 90 degrees, certain portions were close to perpendicular. Moreover, a few small stones were arranged outside the southeast and northwest areas of the pond, spread along the border of the pond's mouth and measuring about 0.6–0.7m wide. Outside the northwest corner of the pond, the accumulation of small stones was comparatively dense and untidy. Dissection revealed the pile to be 0.4m thick, generally consisting of 2 layers, with certain areas containing 3 layers. The ramparts were constructed entirely from natural stones from Mt. Mang 芒山, to the north of the Shang city at Yanshi; most were whitish-gray in color and comparatively solid, with a few comparatively soft, red stones mixed in.

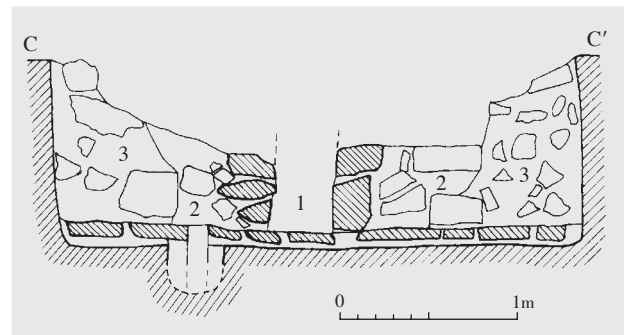
Figure 3. Cross section of the western waterway of the palatial garden pond

1. reconstructed waterway 2. reconstructed parts 3. stone walls of the early waterway

to 100 degrees, it proceeded basically in an east-west direction. Excavation made it clear that the waterway had undergone two periods of use. During the second period, the originally laid foundation was still used, but the central portion of the original waterway was reconstructed in smaller, narrower form (Figures 3 and 4).

The early waterway was 3m wide and almost 1m deep, with steep, straight walls and a layer of flat rocks spread across its floor. The stone walls lining it were 0.6–0.7m wide and 0.8–0.9m thick. The center of the waterway was 1.6m wide. The inner portions of the north and south walls, as well as the margins of the inner edges and the central area of the waterway, all had provisions for setting up pillars, beneath most of which were placed foundation stones. The floor of the waterway was quite even; according to measurements taken with a level, the height of the stones differed by no more than 10cm across the entire length of 54m excavated.

The reconstructed waterway was formed by fitting new stones snugly to the two walls of the original waterway. For the most part, the original stone walls retained their shapes, though a few sections were partially removed. After reconstruction, the waterway was 0.5m wide; the newly constructed stone walls were 0.45–0.5m wide and nearly 0.8m high. Where it passed through the first and second period western palace walls, the waterway was comparatively narrow, with slabs of stone covering it and comparatively large numbers of stone fragments atop it. This was particularly true of its intersection with the second period wall, at which a double-layered waterway was employed to strengthen security; stone slabs were placed in the middle as dividers, forming upper and lower levels. The upper was 0.2–0.3m high and the lower 0.3m high. The floor of the lower level was lower than that of the waterways on the two sides of the city wall. Except at the western palace wall and other individual locations, covering stones for the rebuilt western waterway were not discovered.

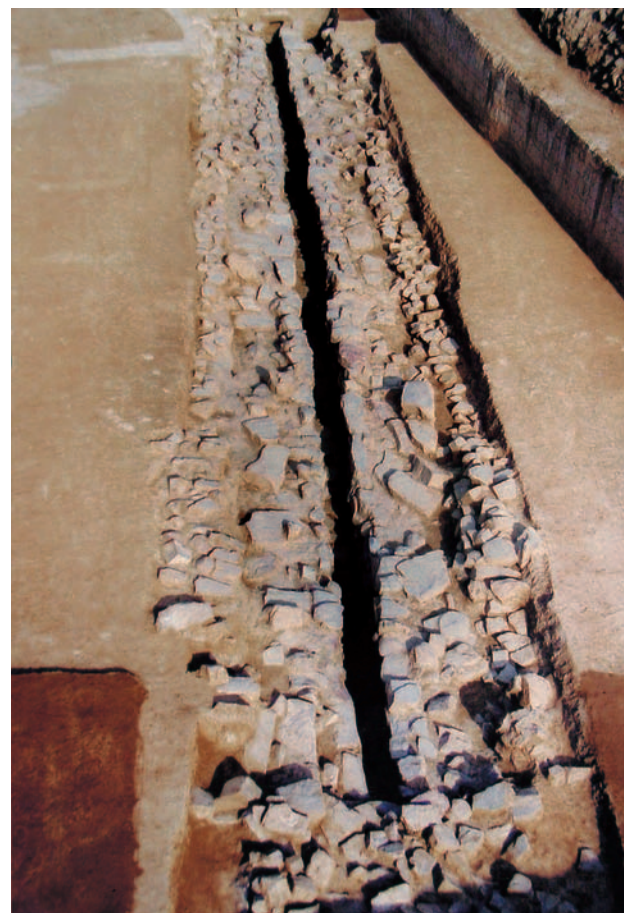
Figure 4. Part of western waterway (photo taken from west to east)

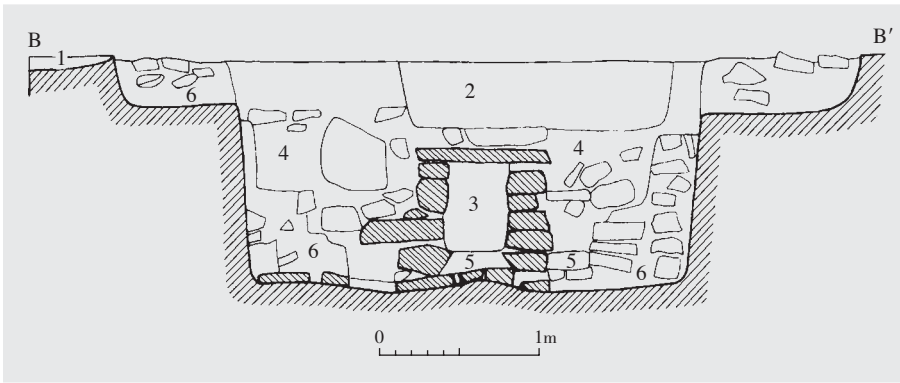
Figure 5. Cross section of the eastern waterway of the palatial garden pond
1, 2. ash layers 3. reconstructed waterway 4. reconstructed parts 5. silt in the early waterway 6. stone walls of the early waterway

form, and the waterway was concealed underground by covering the top with large stones that were in turn covered with soil (Figures 5 and 6).

The early waterway was 1.5m wide at the center and 1.4m deep. Its horizontal cross-section formed the convex shape of an inverted \square -shape; The upper portion was 4.65–4.80m wide at the mouth and 0.3–0.4m deep, while the lower portion was 2.7m wide and 1m deep. The floor of the waterway had been intentionally paved and packed and was covered with a layer of sheet rock; the stone walls lining the trough were 0.6m thick below and 1.3–1.5m thick above.

way lying inside the palace was 0.35–0.38m wide at the center and 0.5–0.6m deep, with stone walls measuring 0.6–1.2m thick. The layer of covering stones consisted mainly of stone strips generally ranging from 0.7–0.9m in length, the longest measuring 1.32m, with occasional triangular stones mixed in. The layer of soil atop the covering stones was 0.2–0.4m thick and had undergone minor processing. At the point of contact, the western section of the eastern waterway reached nearly 1m into the pond. When the waterway was rebuilt, the eastern wall of the palace was partially demolished and repaired after the reconstruction of the waterway was complete. The silt found within the eastern waterway consisted of two distinguishable layers.

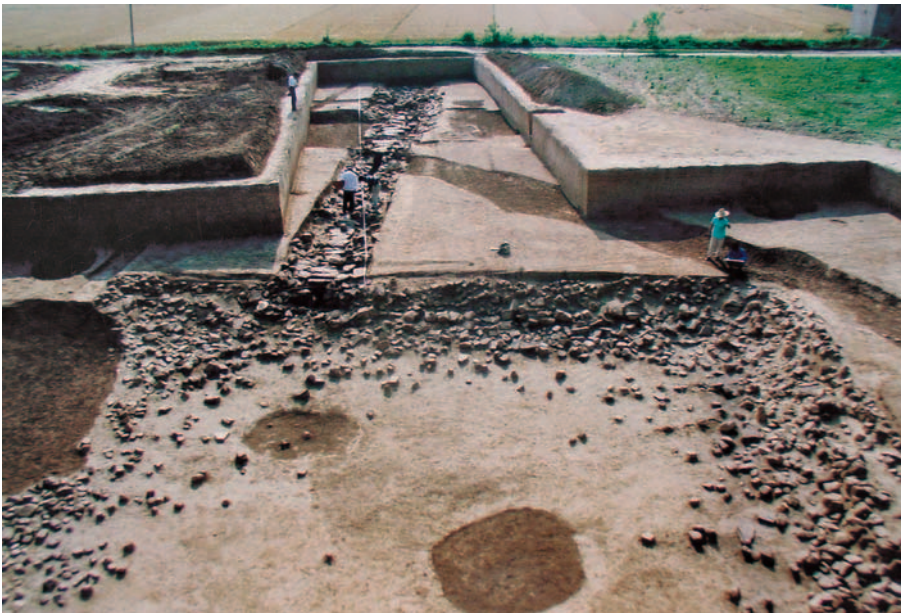
Figure 6. Part of palatial garden pond and eastern waterway (photo taken from west to east)
