Architectural Foundation III of the Northern Wei Palace found at Han-Wei Luoyang City, Henan

Institute of Archaeology, Chinese Academy of Social Sciences and Nara National Research Institute for Cultural Properties, Japanese National Commission for Protection of Cultural Properties

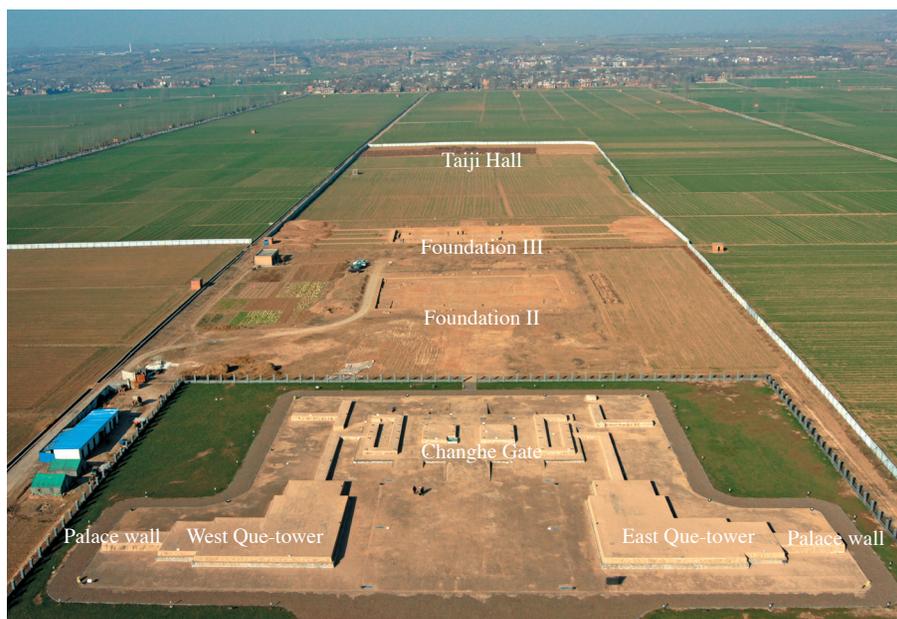
Figure 1 The location of architectural Foundation III of the Northern Wei palace in Han-Wei Luoyang City.

raised rammed earthen foundation of Foundation III was about 80m due north to Foundation II. The site of the Taiji Hall 太极殿, the largest structure within the imperial city, was located directly to its north (Figure 1). The spring and fall archaeological field seasons at Foundation III together revealed a total of about 1800sq m.

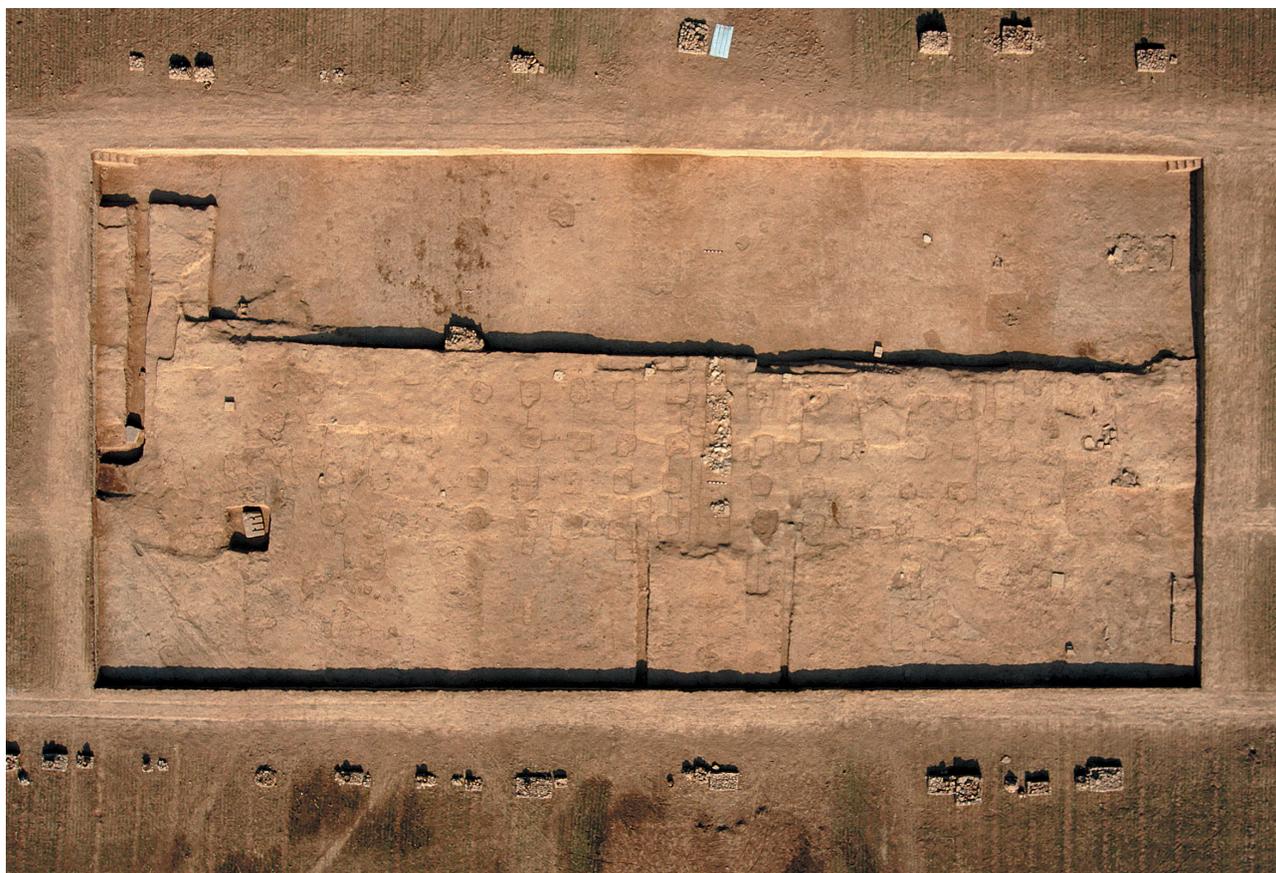
Figure 2 Foundation III (top is north).

the main structure and the subsidiary wing structures of Foundation III (Figure 2). The main structure was a large-scale hall style architecture erected on a raised earthen foundation on which a column framework was set. It had a side door on each of the east and west flanks of the building. The side doors opened to two north-protruding wing structures built on independent rammed earthen foundations. This is a new-found building plan that has never been encountered in the archaeology of Han-Wei Luoyang City. Compared to the Changhe Gate and Foundation II, the other excavated structures of the imperial city, Foundation III showed a distinct plan. Yet, it was built with the same construction techniques and structures. These characteristics, on the one hand, suggested the special position of Foundation III in the imperial city. On the other hand, they exhibited integrity with the general plan and were indicative that all these structures were constructed within a single construction campaign.

The excavation revealed that 48 column base pits were arranged in tidy lines on the raised rammed earthen foundation. They were organized into 14 rows, constituting a column framework shoring a grand hall structure. The framework was divided into one inner grid and two outer grids. The inner grid comprised of 10 east-west rows and four north-south columns, suggesting a three-bay deep and nine-bay wide partitioning. The east and west sides of the inner grid was flanked by 2 x 2 outer grids, forming side chambers of one-bay deep and two-bay wide. As a whole, the grand hall was partitioned into a thirteen-bay wide and one- to three-bay deep structure. The column base pits were not completely evenly spaced. With exceptions of the center units, the bays along the east-west line were 2.3–2.5m wide. The central bay, measured 4.9–5m from east to west, were the longest. The bays along the north-south line were 2.2–2.5m wide. Because of later disturbance, the openings of column base pits showed irregular rectangle shapes of varying size when they were discovered. In general, they measured 0.9m on one side. The column base pits were filled with disturbed materials consisting of large amount of polished tile sherds. A few column base pits were intruded by later occupations. The column base pits not only cut into the rammed earth foundation, they also cut into the reddish brown rammed earth partitioning walls and platforms.

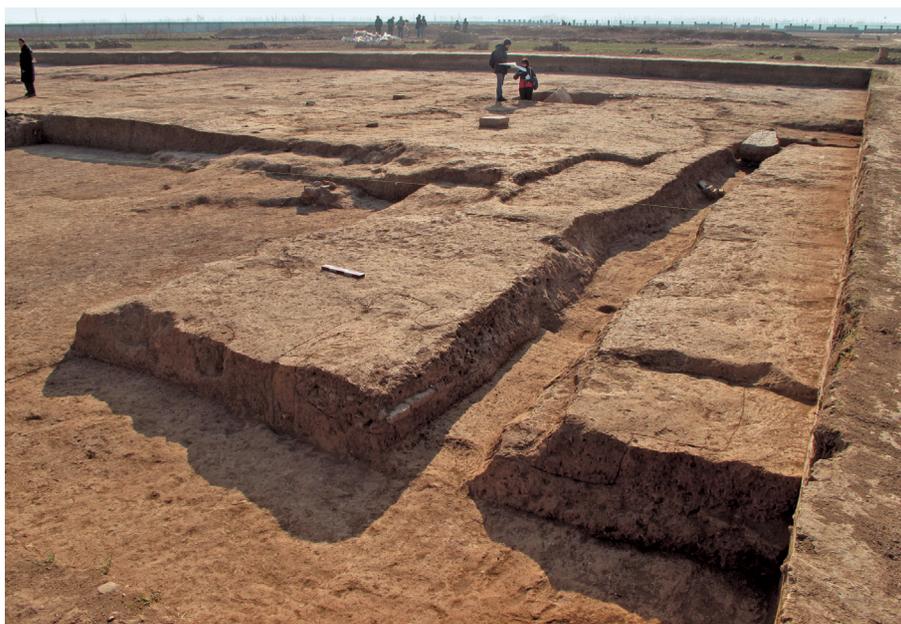
Figure 3 The subsidiary structure and drainage ditches to the west of Foundation III (NW–SE).

Remains of an independent subsidiary structure that included a rammed earth foundation and ditches were found adjacent to the west of the west side door (Figure 3). This wing structure extended about 8m north of the main structure. It was connected to the main structure by the side door and short walls. Its overall plan could not be determined due to limited excavation and poor preservation. Remains of ditches were found located on the west and the south sides of the wing structure. Some lining bricks were found at the base of the ditches. The north-south running ditch was about 13.5m long. It had an opening about 1m wide and a base that measured 0.5–0.7m. Depositions of the ditches comprised of large amount of brick and tile fragments. The tile sherd assemblage comprised of polished flat tiles and cylindrical tiles diagnostic to Northern Wei. Subsurface coring indicated that a similar wing structure built of rammed earth was symmetrically distributed on the east side of the main structure. Future excavation will reveal its dimensions.

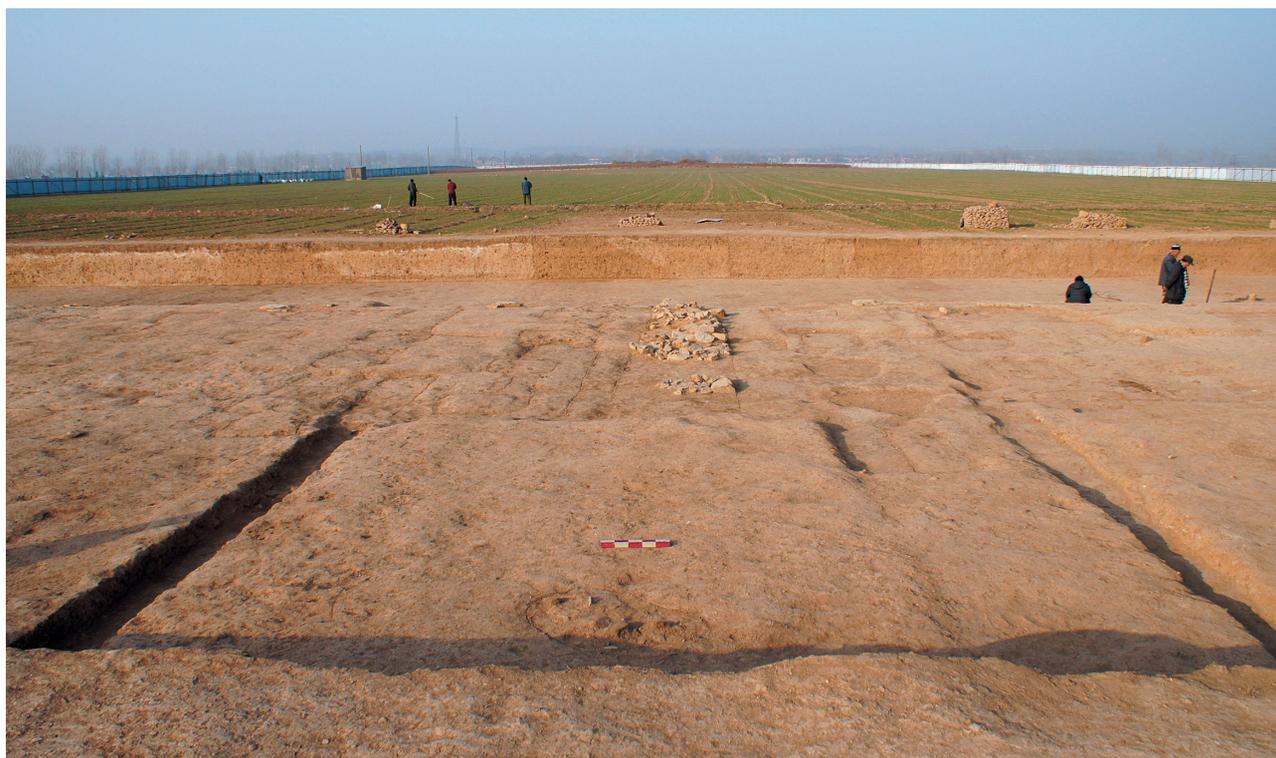
Figure 4 The “imperial boulevard” to the south of Foundation III (S–N).

Remains of a section of road surface of 7.9–8m wide were found on the center of the south side of the main hall foundation (Figure 4). The surface had been heavily disturbed. Shallow brick-lined ditches of 0.25–5m wide and 0.3m deep were found along both the right and the left sides of the road. Land survey indicated that this section of road was straightly on the same axis with the brick-lined road located in between the Changhe Gate and Foundation II of the imperial city. Their identical dimension and orientation suggested that they were different sections of the same imperial boulevard. The dates of its construction and using should not be later than Northern Wei. Occupation floors were found to the north and south sides of the main raised foundation. The south occupation floor had dark grey color with inclusions of reddish baked earthen nodules. The north occupation floor comprised of leveled rammed earth. Its surface had been hard-packed or processed.
