## The excavation of the house remains of Yangshao Culture at Xiahe Site in Baishui County, Shaanxi

Shaanxi Provincial Institute of Archaeology

In 2010, the Shaanxi Provincial Institute of Archaeology excavated the Xiahe Site located at Xiahexi Village in Baishui County, Shaanxi Province. The outstanding findings included three large-sized house structures featuring pentagonal plans, inner and outer walls, and lime-plastered floors made from calcareous nodules (*liaojiang*). F1 was the largest of the three structures. The assemblage of material remains comprised mainly potsherds, as well as some stone, bone and shell artifacts. The potsherds from F1 showed pottery assemblage of pointed-bottomed bottle, bowl, basin, jar, *zeng*-steamer and lid. That from F2 showed pottery assemblage of pointed-bottomed bottle, bowl, basin, jar and vat. The style of material remains chronologically placed the Xiahe occupation to the late Miaodigou Phase. The findings are significant to the study of architecture, settlement pattern and economy of the Yangshao Age.

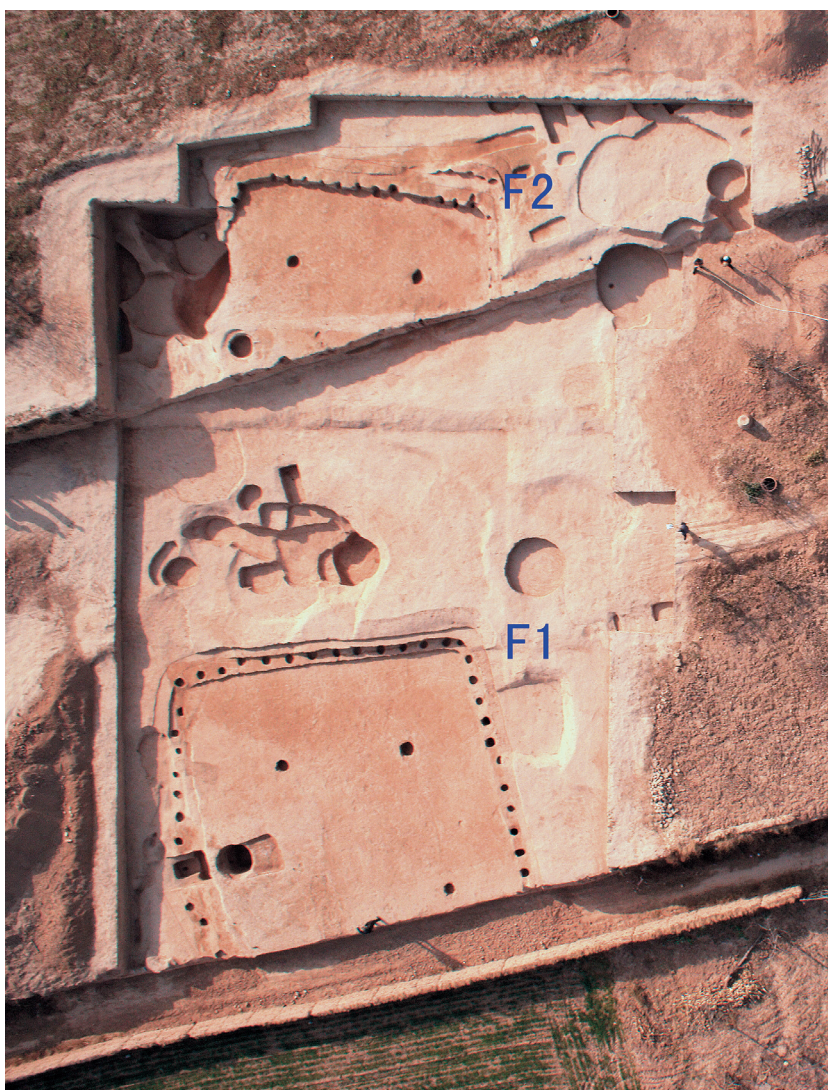
Figure 1 The full-view of the excavation area in 2010 (top is west).

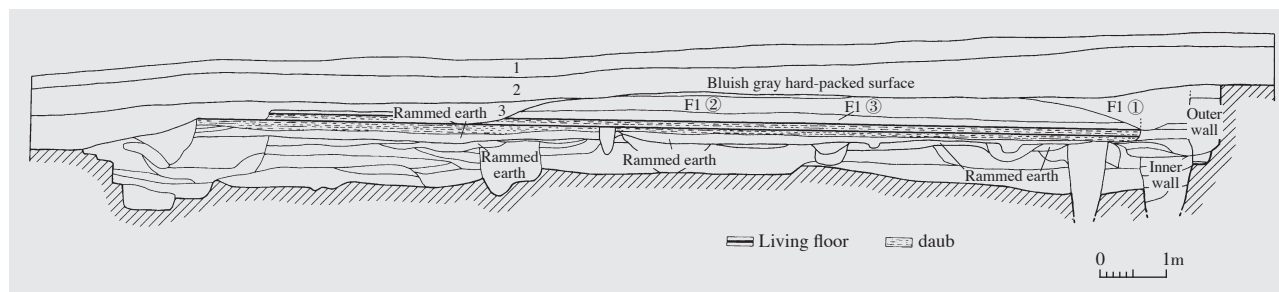
**Figure 2** The cutaway section of the foundation of F1.

1. The till zone; 2. Yellowish gray soil; 3. Yellowish gray soil; F1 ①. Yellowish gray soil; F1 ②. Yellowish gray soil; F1 ③. Bluish gray soil.

The deposition formed after the abandonment of F1 could be divided into three layers. Layer 1 and Layer 2 were debris of the collapsed walls. Layer 3, distributed all over the feature, was likely the remains of the collapsed roof. Underneath the three layers of deposition were two layers of lime-plastered living floor underneath which was the primary loess (Figure 2).

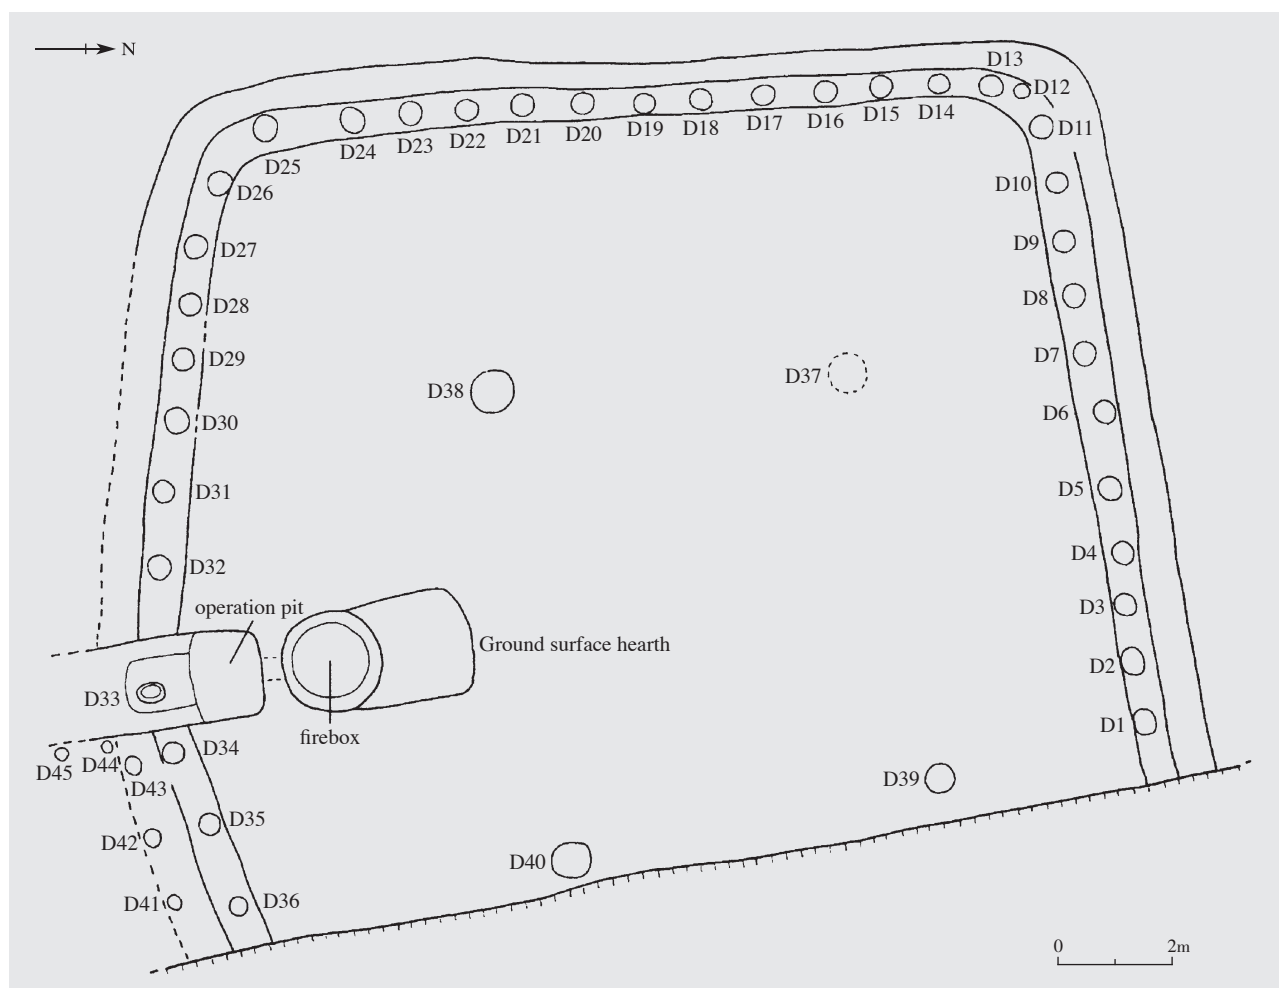
**Figure 3** The plan of F1.  
D1–D45. Postholes.

2. Form and structure. F1 was a pentagonal semi-subterranean structure. The door opened to the south with an orientation of 170° (measured from the axis passing through the centers of the doorway and the hearth). The remaining structure and the remaining living floor occupied 263.4sq m and 217sq m, respectively. Whilst the restored structure occupied 364.85sq m and the restored living floor occupied 304.5sq m. The structure comprised a doorway, a composite hearth, the living floor, the walls, postholes and a semi-subterranean foundation (Figures 3 and 4).

(5) Postholes. A total of 45 postholes were found in F1. They included 35 postholes in the inner wall, three in the outer wall, one in the doorway, two for the doorway shelter, and four in the living area. Posthole D8 in the middle of the north wall measured 45cm in diameter and 1.2m in depth. The cylindrical posthole had a leveled bottom and smooth wall. Fillings of the posthole were blocked by a layer of daub plaster 10cm below the living floor. A second layer of reed daub plaster that measured 40cm in diameter was found inside the posthole and 50cm below the living floor. A layer of 20cm of light gray potash was found at the bottom of the posthole. Underneath the ash deposition was the primary soil. Red pigment (test pending) was found in the upper half of

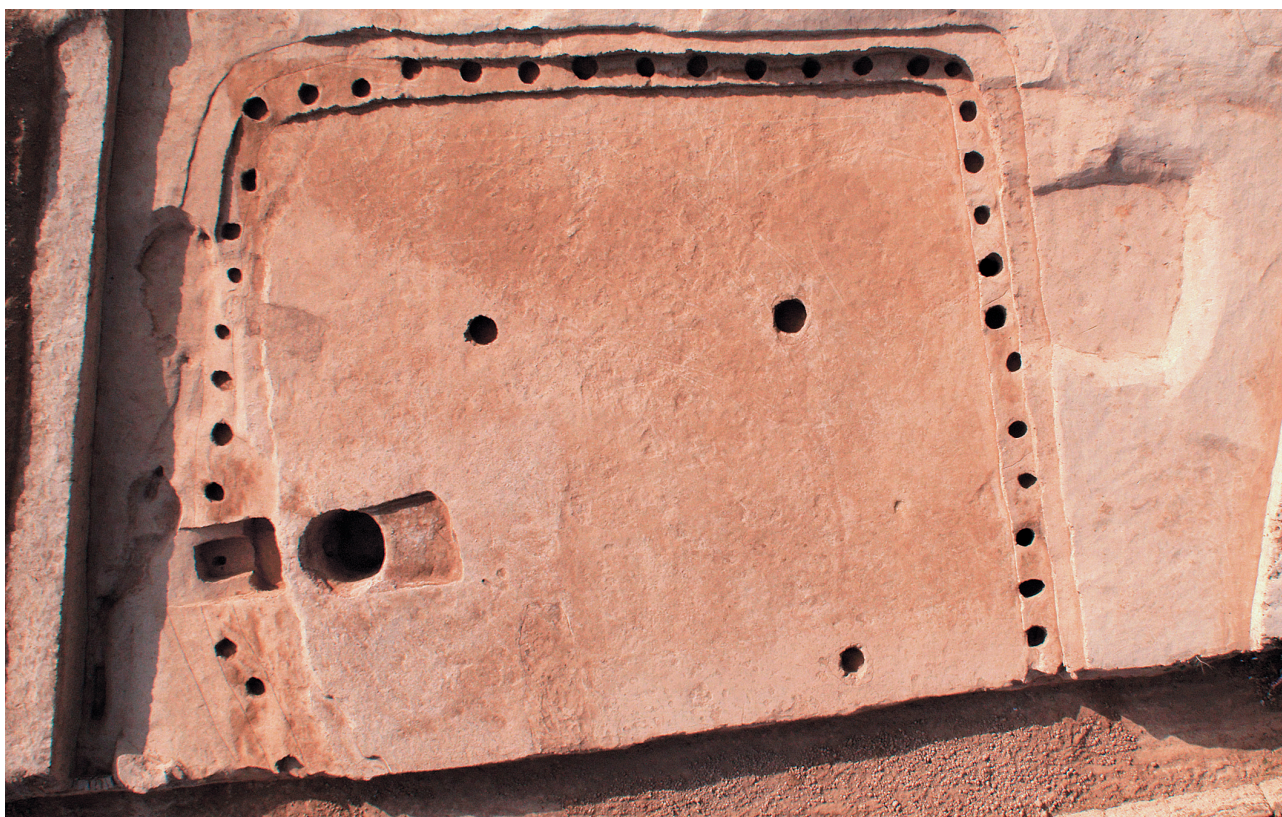
Figure 4 The full-view of F1 (top is west).

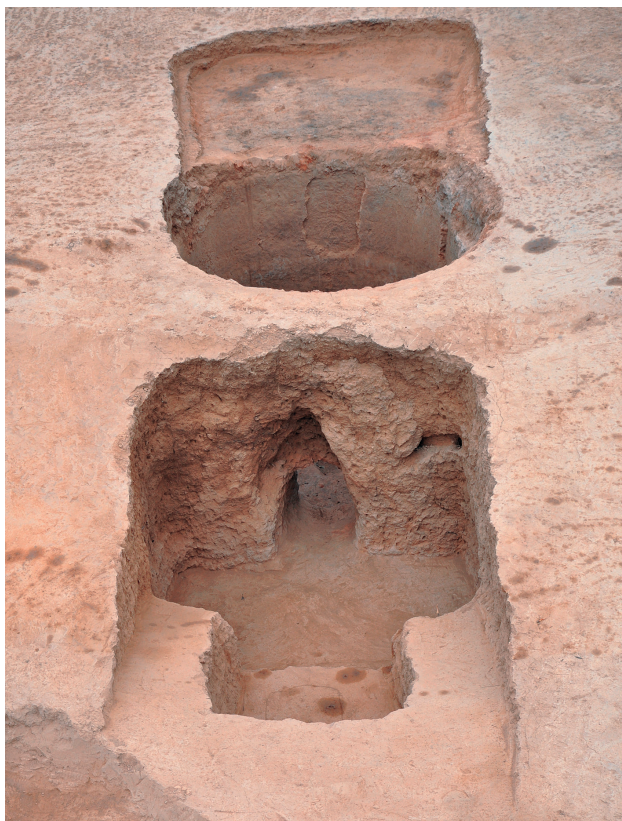
Figure 5 The firebox, ground surface hearth and operation pit of F1 (top is north).

(2) The composite hearth. The composite hearth was located next to the northern end of the doorway. It comprised an operation pit, a fire channel, a firebox, and a ground surface hearth (Figure 5).

The operation pit was a rectangular shallow pit located to the immediate north of the doorway and was 50cm south of the firebox. It measured 1.6m long and 1–1.1m wide with straight walls and leveled floor. Its remaining depth was 1.5m.

The round-cornered rectangular barrel-shaped fire channel situated in between the operation pit and the firebox. It sloped down northward and leveled with the firebox in the north. It measured 40cm wide, about 60cm long, and 70–80cm high. A layer of clay burnt into bluish gray color 2–3cm thick wrapped around its walls, followed by reddish burnt clay 20–30cm thick.

The firebox situated 50cm to the north of the operation room. It had a circular plan with a larger opening and

a smaller base. It measured 1.8m in opening diameter, 1.3m in base diameter, and 2m deep. A 2–3cm layer of daub was applied on the walls and base of the firebox. Continuous exposure to intense heat had turned the wall and base surfaces into thin layers of bluish gray petrified earth followed by reddish burnt earth. The firebox had several petrified layers, indicating that it had been repeatedly amended. Deposit of potashes and charcoal were recovered from the firebox.

Ground surface hearth. The trapezoid hearth located to the north of the firebox. It measured 1.6m long, 1.9m wide in the north, 1.7m wide in the south, and 20cm deep. The uneven petrified bottom of the surface hearth was covered with ashes.

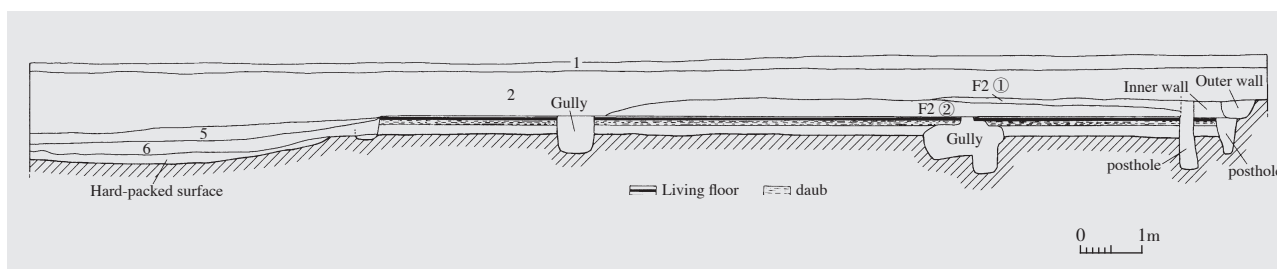
**Figure 6** The cutaway section of the foundation of F2.

1. The till zone; 2. Yellowish gray soil; 3. Yellowish gray soil; 4. Brownish gray soil; 5. Brownish gray soil; 6. Light gray soil; F2 ① . Yellowish gray soil; F2 ② . Light gray soil.

The simple deposition of the features comprised two layers. Layer 1 was a yellowish gray deposition comprising large quantity of burnt clay and daub clods from the collapsed walls. Layer 2 was a light gray deposition tempered with small number of baked clay nodules and charcoal, which were likely remains of the collapsed roof (Figure 6).

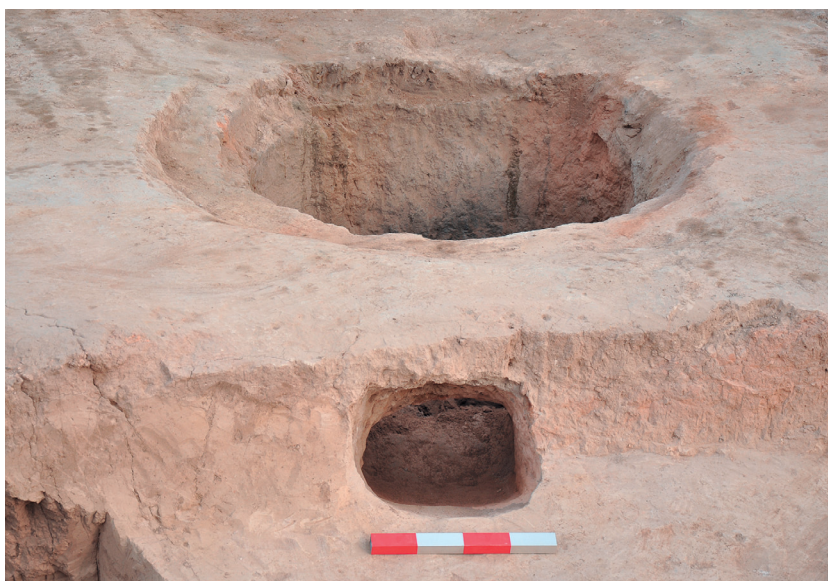
Figure 9 The hearth of F2 (S-N).

(2) Composite hearth. The hearth comprised a firebox and a fire channel. The fire channel was between the doorway in the south and the firebox in the north. The round-cornered rectangular barrel-shaped fire channel was dug into the living floor, higher in the south, sloped downward to the north and leveled with the firebox. Its walls showed a bluish gray hard-burnt surface, followed by a layer of burnt earth. The walls were plastered with a layer of daub. Two hard-burnt layers had been formed. The firebox comprised two layers. The first layer was loose yellowish gray earth; wherein the second layer comprised ashes (Figure 9). The firebox of F3 was superimposed by the firebox, living floor and doorway of F2. Because of that, its shape and structure could not be made clear. It measured 1.4m in diameter and 90cm in depth. Its walls and base were lined with a bluish gray hard-burnt surface.
