Report

of Egyptian-Chinese Mission at Montu Temple, Karnak

(2018-2019)

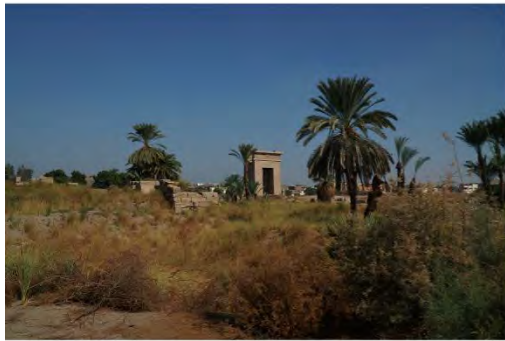
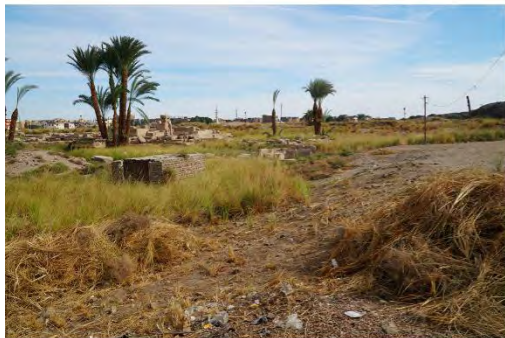
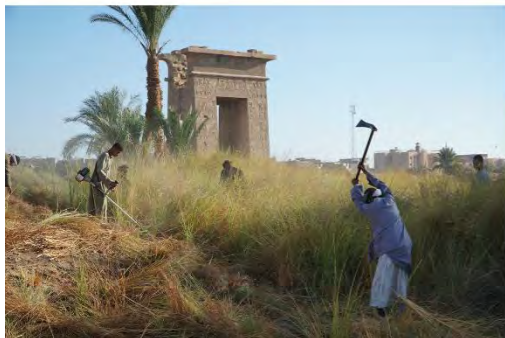
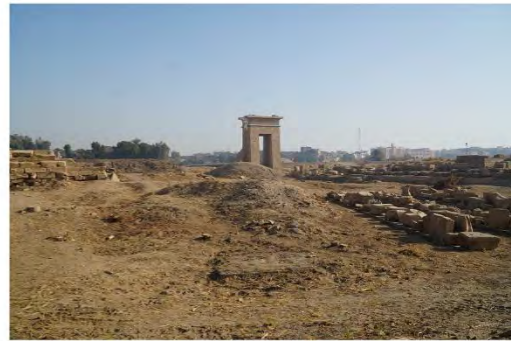
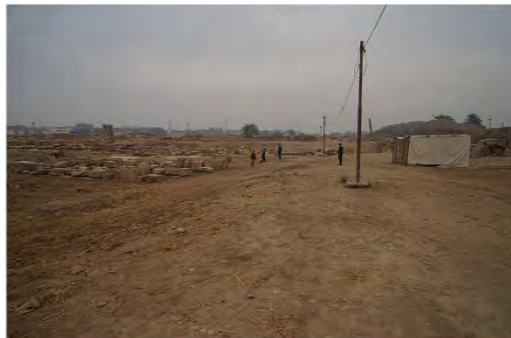
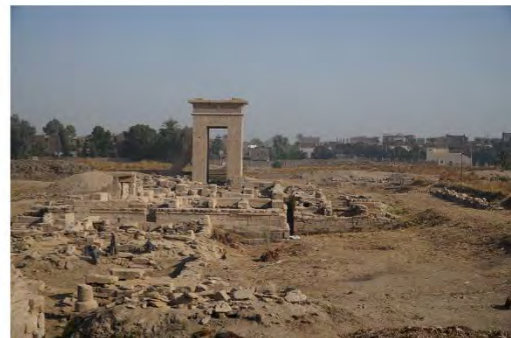
Fig. 1 The photos show views before cleaning (left) and after cleaning (right). ©MTP

The site was full covered by vegetation, including the palm trees, a kind of strong wild grass, and also the domestic trashes all year long, the rests of wild animals, some mounds in height 2-5m which was made by the old excavations. The main job of this season is indeed cleaning the surface of the whole site to provide a suitable situation for the archaeological surveys and other necessary works forthcoming (Fig. 1).

As a part of the plan made by Egyptian - Chinese team, the cleaning work carried out on the following parts of the site during this season:

- Inside the enclosure walls of the Montu Temple, the wild grasses have been cut and moved out of the site; fifty-seven different size palm trees have been all cut down and removed for an open view of the site and also for the aerial photos which we expect to take during the next season.

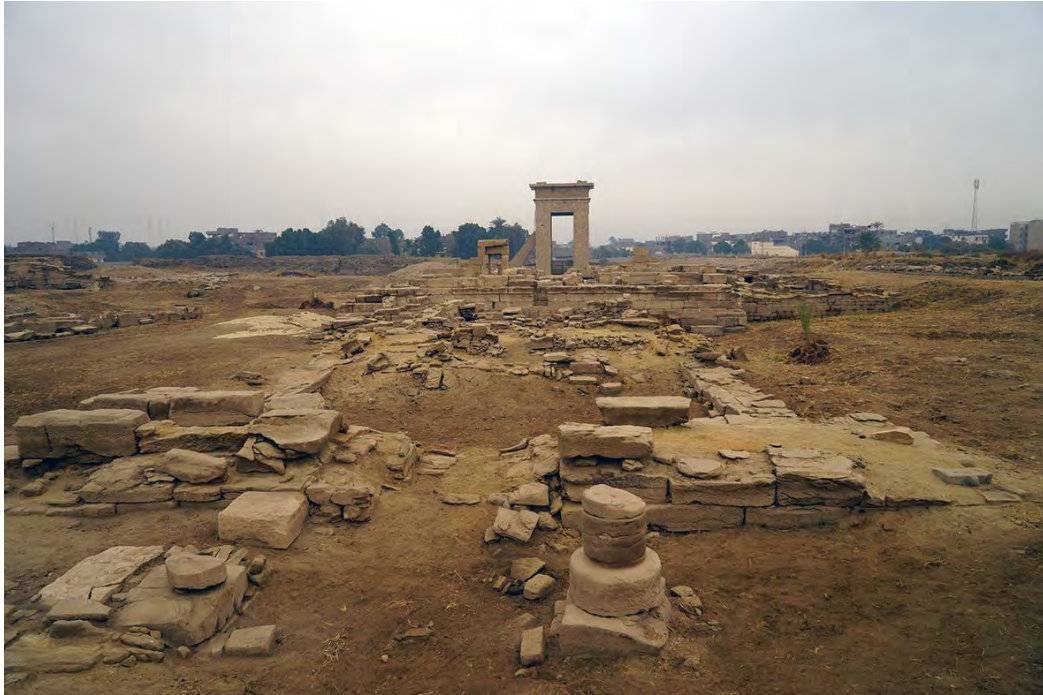
Fig. 2 South view of the three temple after cleaning. ©MTP

- Three temples: the Montu temple, Maat temple and Harpre temple (Fig. 2).

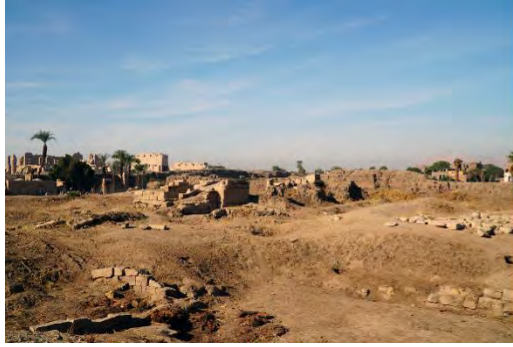
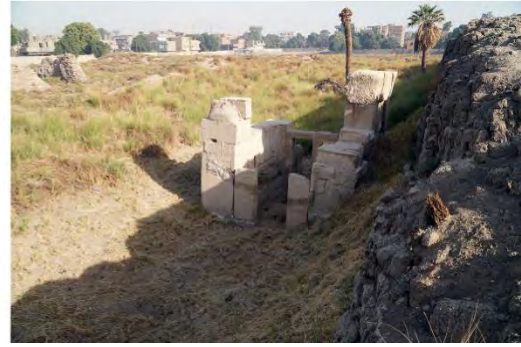
Fig. 3 Left: North-east view of the "High temple". Right: South view of the gate of Thutmosis I.
©MTP

- A high structure, also named “High temple”, with its mud bricks foundation and a sacred lake with structure of steps nearby (Fig. 3: Left).
- Six Osirian chapels behind the six gates on the south wall, only two of them rest upper structures on the ground: Chapel of Nitocris and Chapel of Amenardis.
- The gate of Thutmosis I outside of the west wall, on the same axis as the southern gate (foundation only) and the gate of Ptah (Fig. 3: Right).
- The gathered blocs and mastabas lay on the site and its surrounding area.

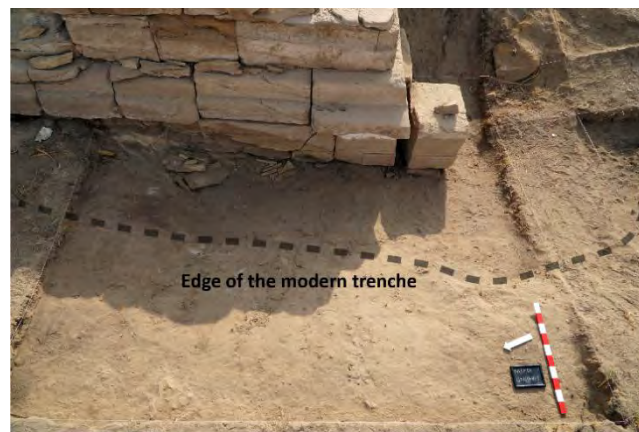
Fig. 5 View of the south-west corner of the Montu temple after cleaning show the modern trench.

3 grids (5m x 5m) are set up in this zone, ceramics and some sand stone blocks are gathered. During the cleaning, we discovered the French trench around the south-west corner of the Montu temple (in the grid G3760-885), but the trench seems very deep and we only reach the surface level (Fig. 5). A small mud-brick wall has been also found on the west side of the Maat Temple (in the grid G3750-885).

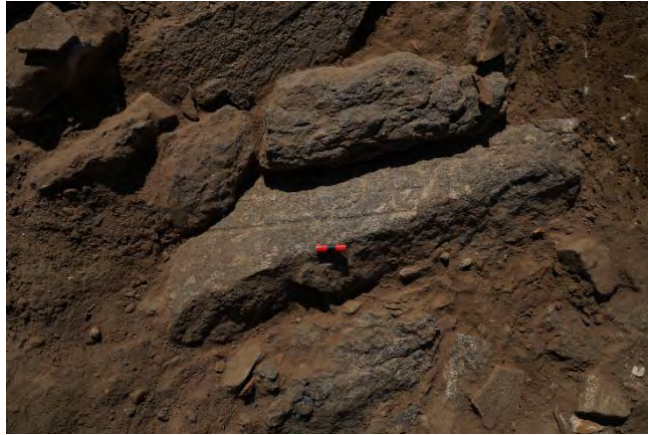
Fig. 6 Granite fragments show a cartouche probably related to a female name, found in front of the Amenardis's chapel. ©MTP

20 grids (5m x 5m) are set up in this zone, ceramics and some sand stone blocks are gathered. The limits of old excavation led by IFAO are identified benefit from the cleaning work, which are 20-50cm wide outside of the walls. For the chapel of Nitocris, we noted that the gate and the entrance of the chapel are not exactly on the same axis; 4 bases of the columns don't have the same diameter. For the chapel of Amenardis, it seems has another structure on the west side of the chapel, some foundations reveal out after cleaning. In front of the chapel's entrance (in grid G3720-815), some granite fragments with a half cartouche is discovered, it seems to belong to the dorsal pillar of the statue. The owner of this statue should also be a priestess (Fig. 6).

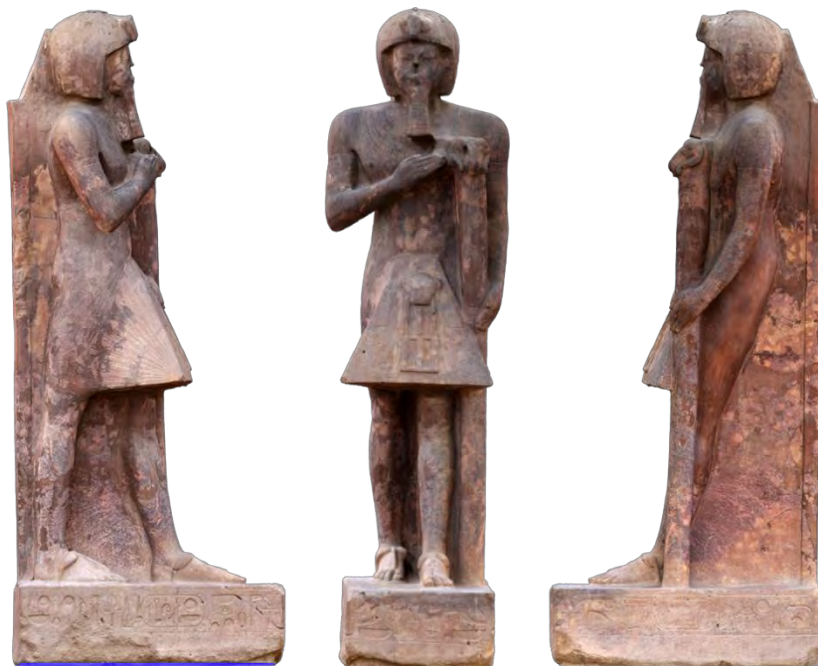
Fig. 7 Statue of Amenhotep III with three different views based on a reconstruction on 3D models. ©MTP

The photogrammetry is the science of making measurements from photos. This technique has been widely applied for recording different information at archaeological sites. Based on this technique, we can also build the 3D model that allows all information to present in a system dimensional. Three 3D models (Fig. 7-9) are made during this season by Ibrarim Mustafa (MoA).

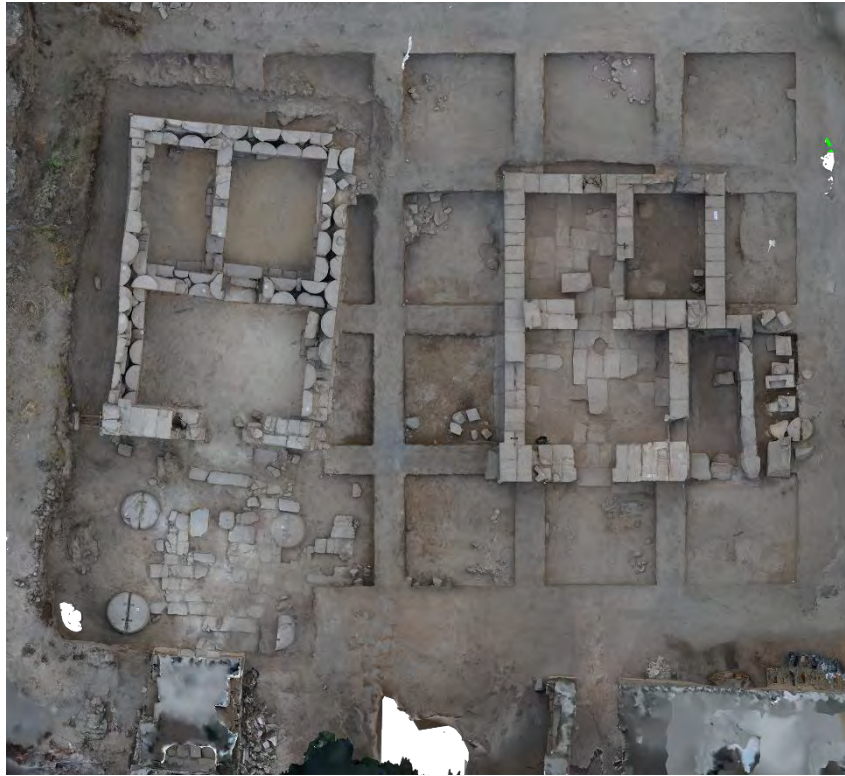
Fig. 8 Orthoprojection view of the two Osirian chapel based on 3D modeling. ©MTP

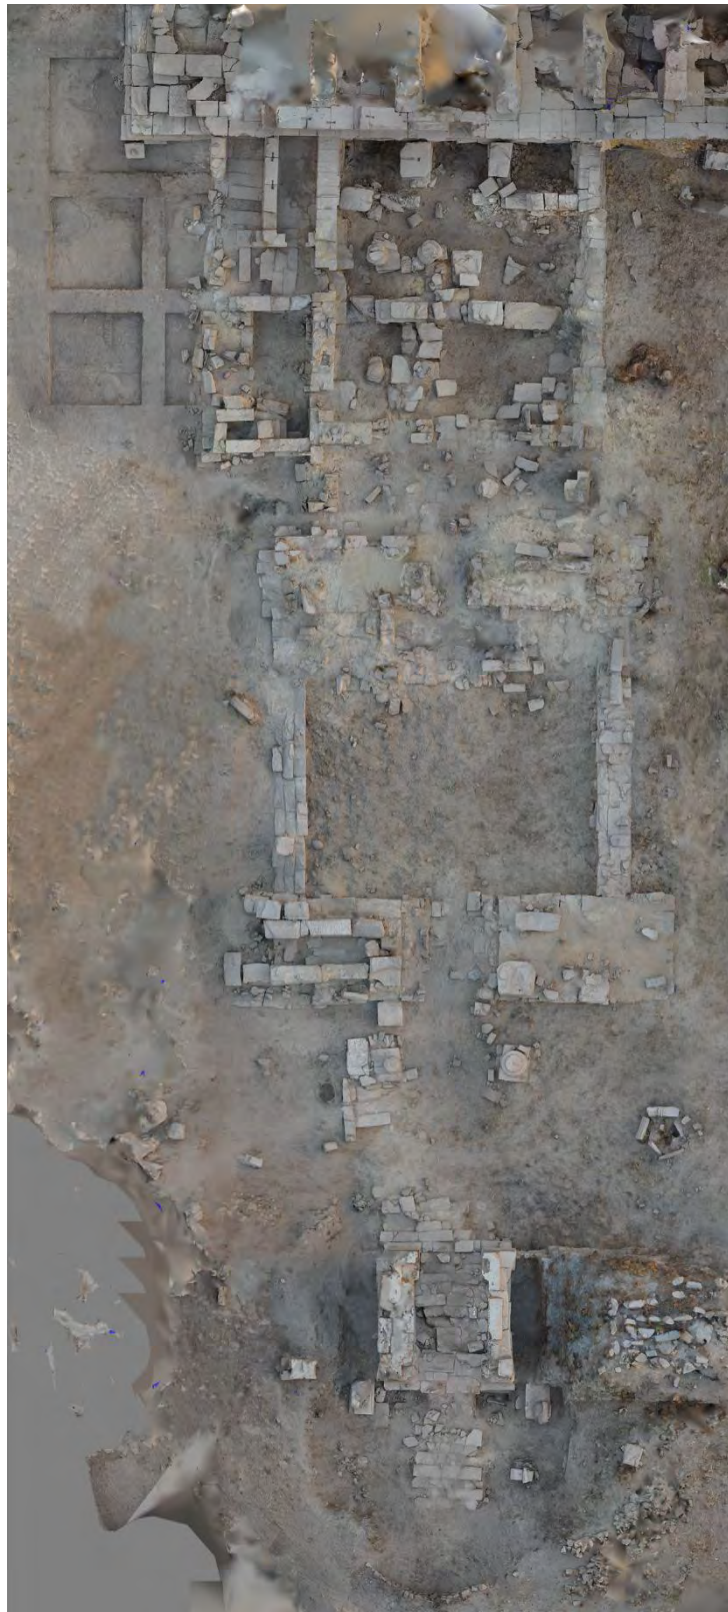
Fig. 9 Orthoprojection view on Maat temple, based on 3D modeling. ©MTP

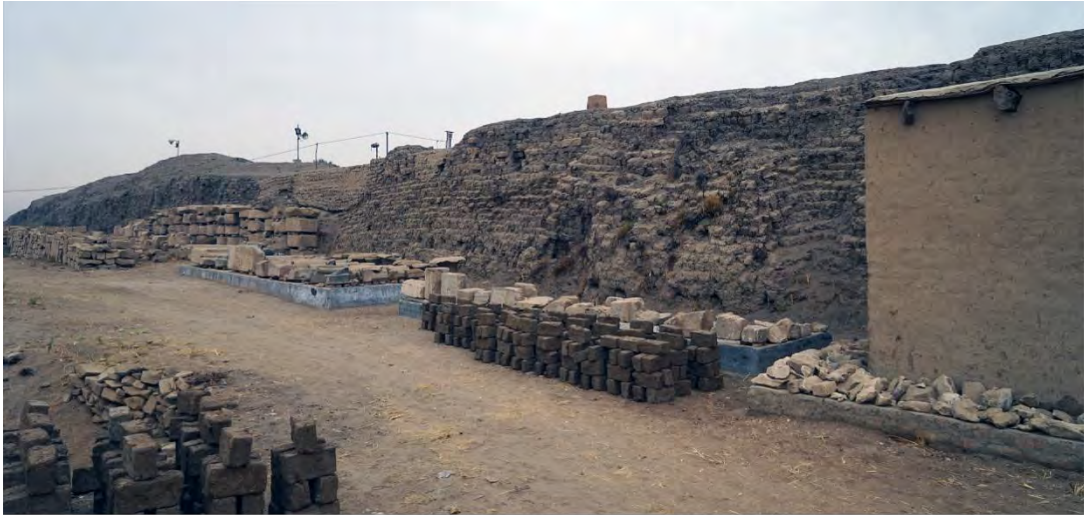
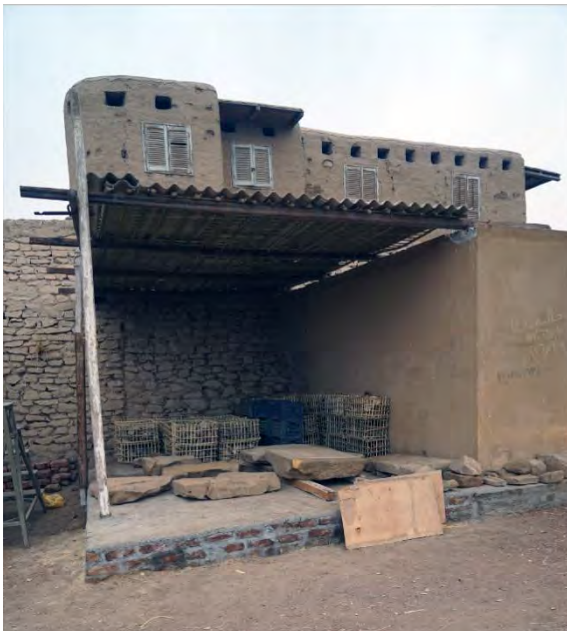
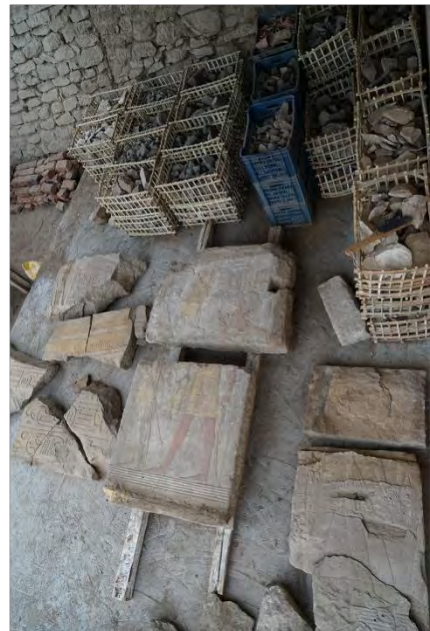
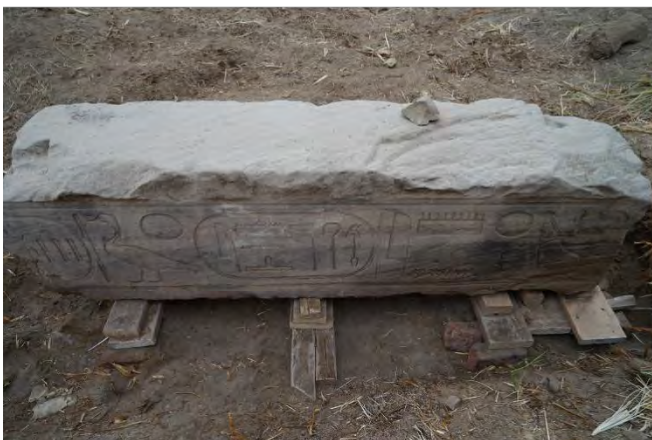
Fig. 10 Three new mastabas built during this season for conservation and some emergency measure.

These blocks are damaged ceaselessly because of soil corrosion and wind erosion. One big mastaba and other smaller one are built on the place (5) during this season for the purpose of conservation. A sunshade is also built between the two

storerooms for keeping the wooden baskets and the fragments in the shadow (Fig. 10).

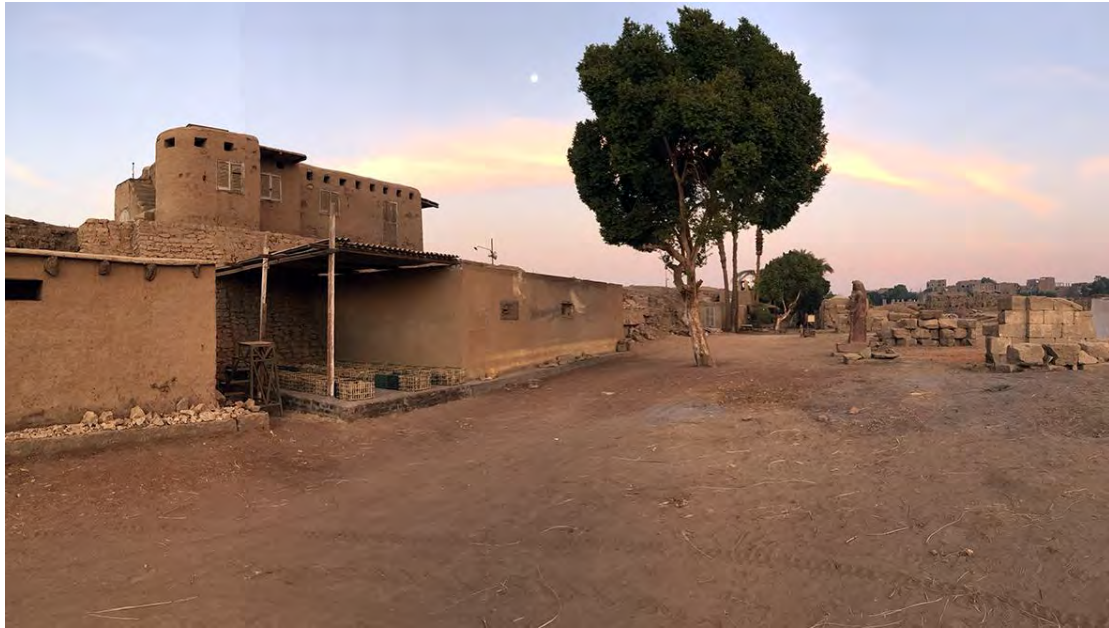
Fig. 11 A clear view on the office area after cleaning and remove the modern buildings. ©MTP

Cleaning the office area; Six modern buildings in the place of the south wall built by IFAO have been emptied and removed; one wooden storeroom has been removed; improved the condition of the kitchen and reused it; new lights have been installed (Fig. 11).
