Egyptian-Chinese Mission at Montu Temple of Karnak

**Report
2019-2020**

Louxor 2020

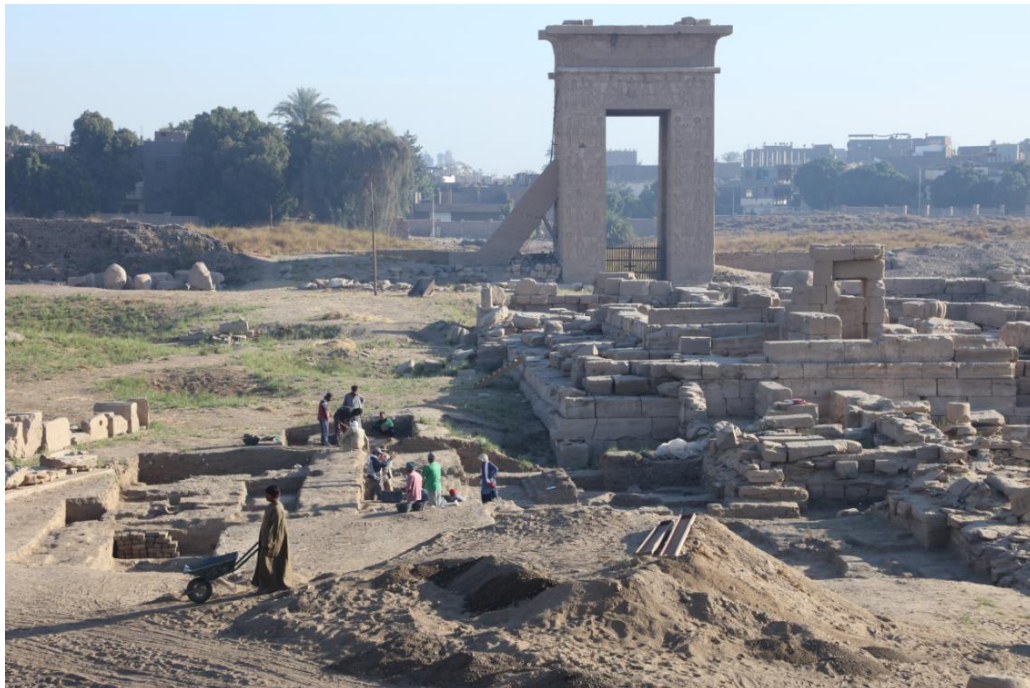
Fig. 4 Area 2 : view to the north © MTP

The excavation revealed several occupation phases. One of the earliest constructions corresponds to a mud-brick ground, semi-buried. Some small wall built directly on this ground seems to separate the space to different rooms. This structure went through to the east under the foundation layer of Maat Temple.

After the construction of the Maat Temple, a three meters wide mud-brick wall built directly against the foundation of the second pylon has been discovered in the south-east part of our excavation.

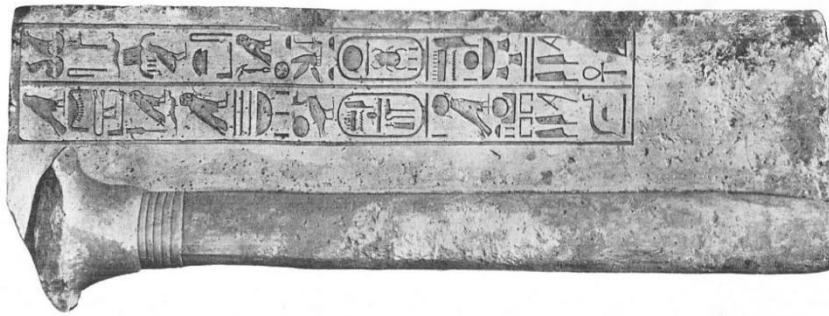
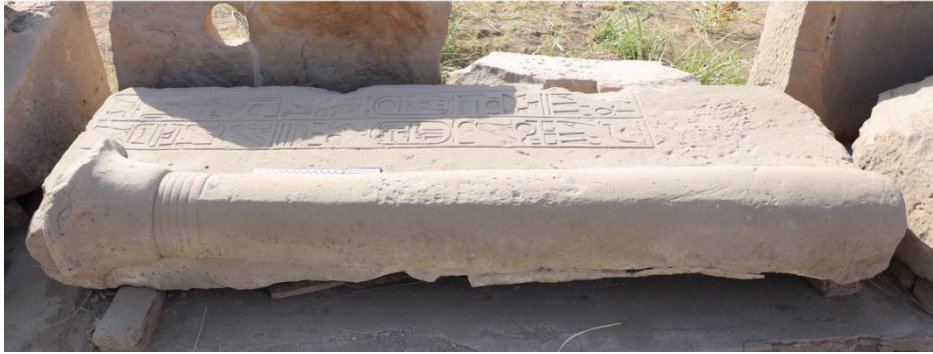
Fig. 7 A doorjam of Amenhotep III conserve on mastaba No. 4 in Group (3) - Varille's Inventaire 219

Inventaire 219.
Colonne engagée d'Amenhotep III remplacée par Amenhotep III.
TEMPLE DE MOSTOU.

Among the studied blocks, most of the small-scale blocks from the previous missions are absent in the reports titled by "Karnak-Nord". The majority of the blocks in Group (3) can be referenced to the first report (*FIFAO* 19) published by A. Varille with the number of "inventaire" (see figures below). Some others are from the excavations directed by J. Jacquet at the Treasury of Thutmose I. For the blocks that found during this season, they are also registered and photographed but the result is limited unless the further studies.

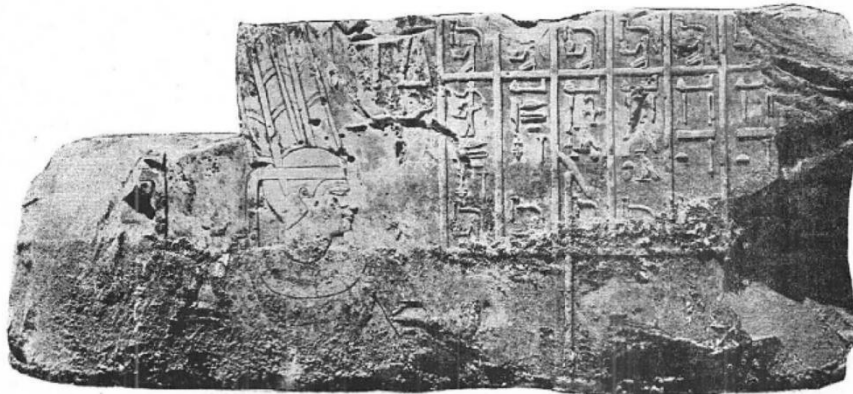
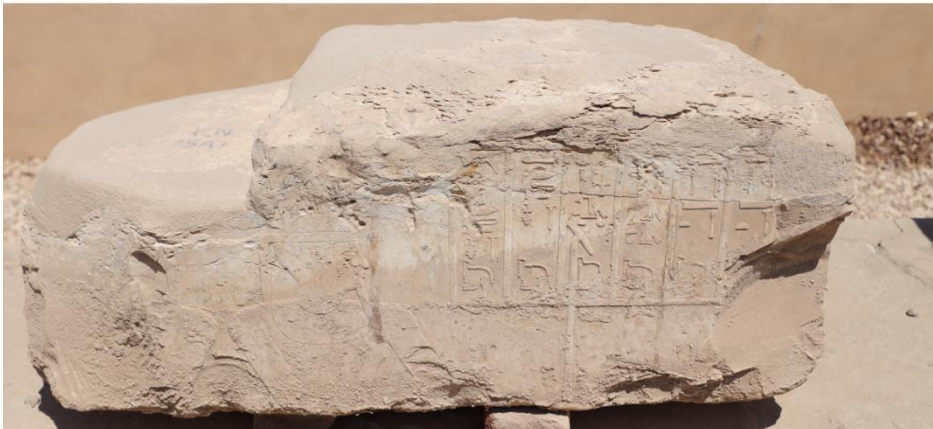
Fig. 8 A limestone block of Amenhotep I conserve in the Open Air Museum of Karnak Temple - Varille's Inventaire 708.

A. — Décoration murale. — Inventaire 708. Face A.

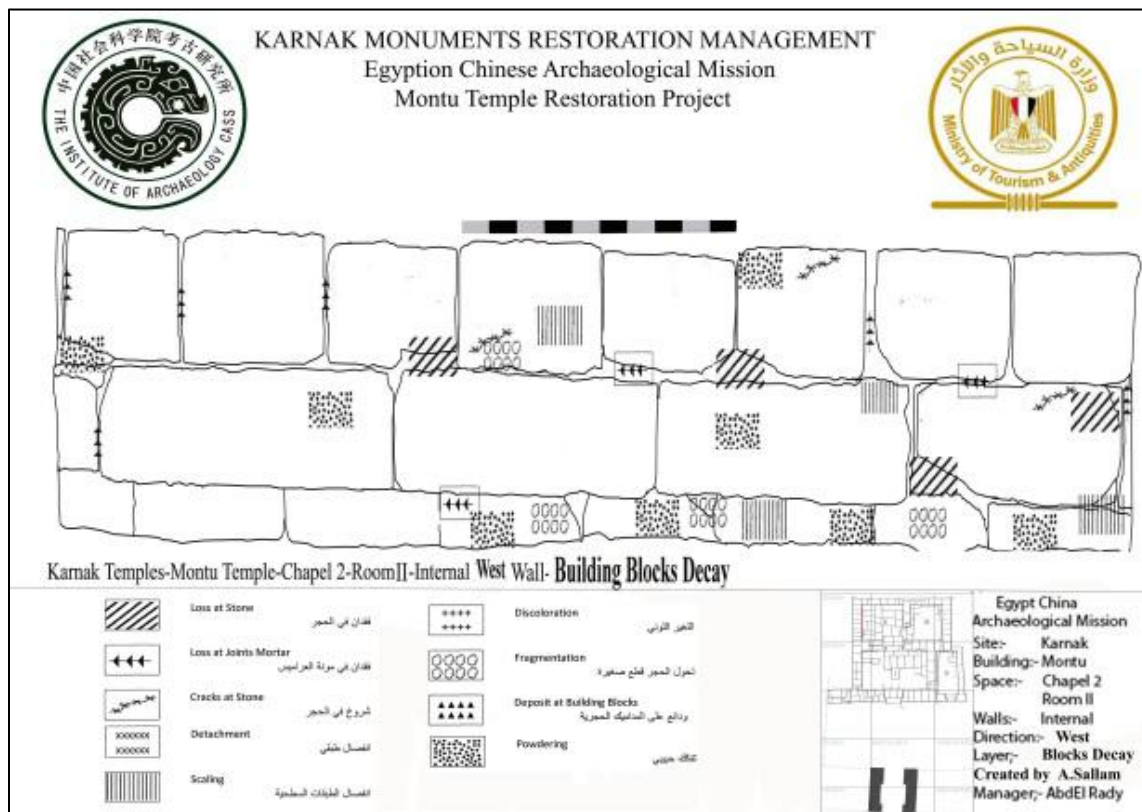
Fig. 9 Documentation of the internal west wall of Room II, the second chapel

The restoration team recorded all decays types and treatment processes at CH2 walls using photo shop program as this example

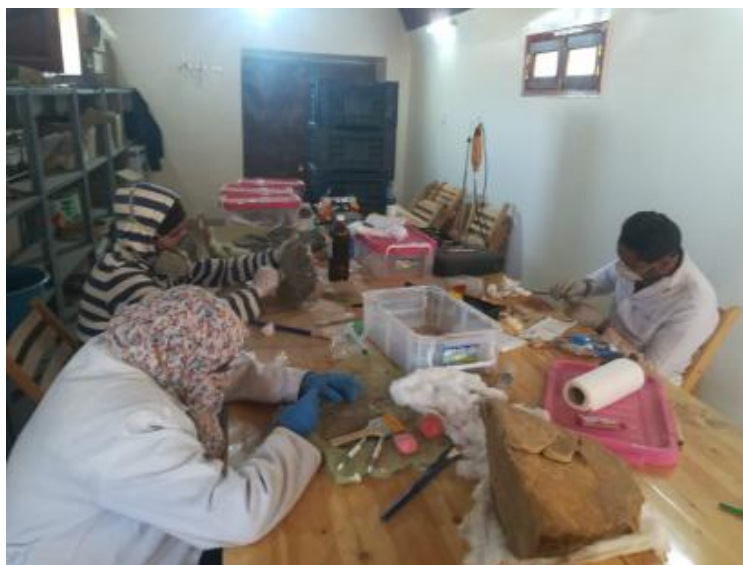
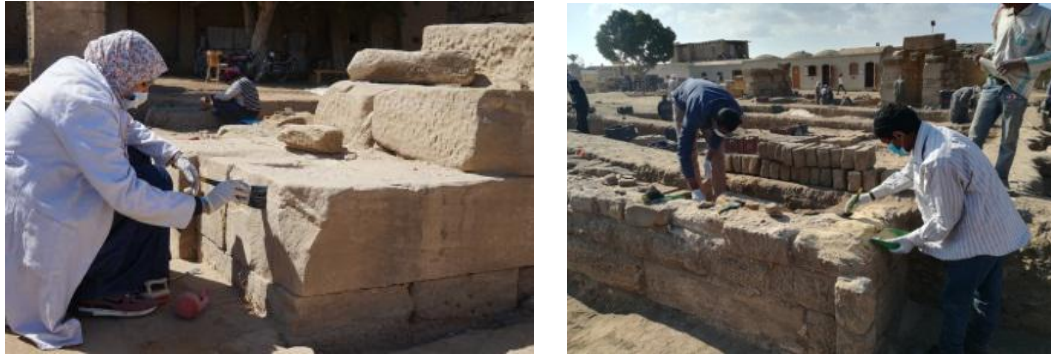
Fig. 10 During mechanical process at CH2, CH3 and small objects inside the lap. © MTP

The restoration team applied the mechanical cleaning for all CH2 blocks and joints, also this process applied for some areas from CH3 and some small objects. Also the team applied consolidation process for all stones and plaster layers that have been cleaned

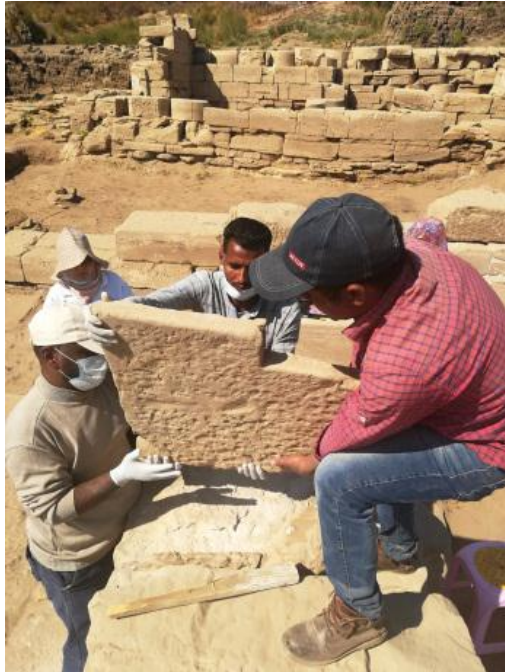
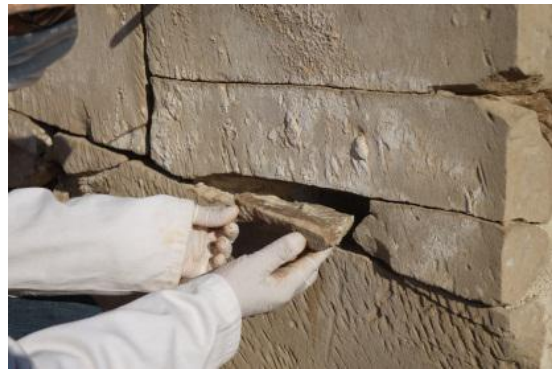
Fig. 12 During injection process and re connecting of fragments © MTP

Due to the fragmentation of most of the chapel's stones, many parts of the stones have been re-connected in original place. And many weak areas and cracks were injected with adhesives and fillers.

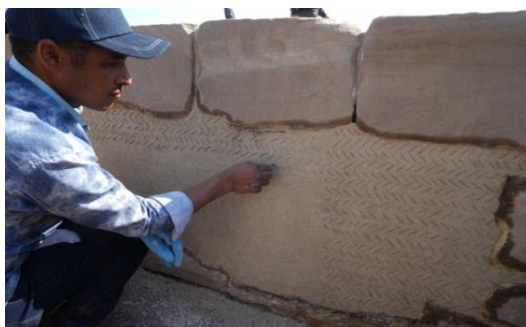
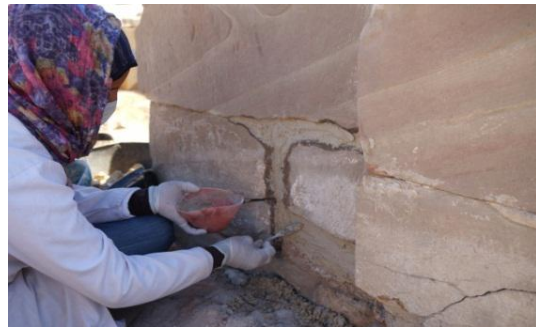
Fig. 13 During filling the joints and the gaps with new lime mortar © MTP

The remains of original joints mortar was consolidated but the open joints and the gaps are filled with new lime mortar. **(Ahmed Sallam, Abdel Rady)**

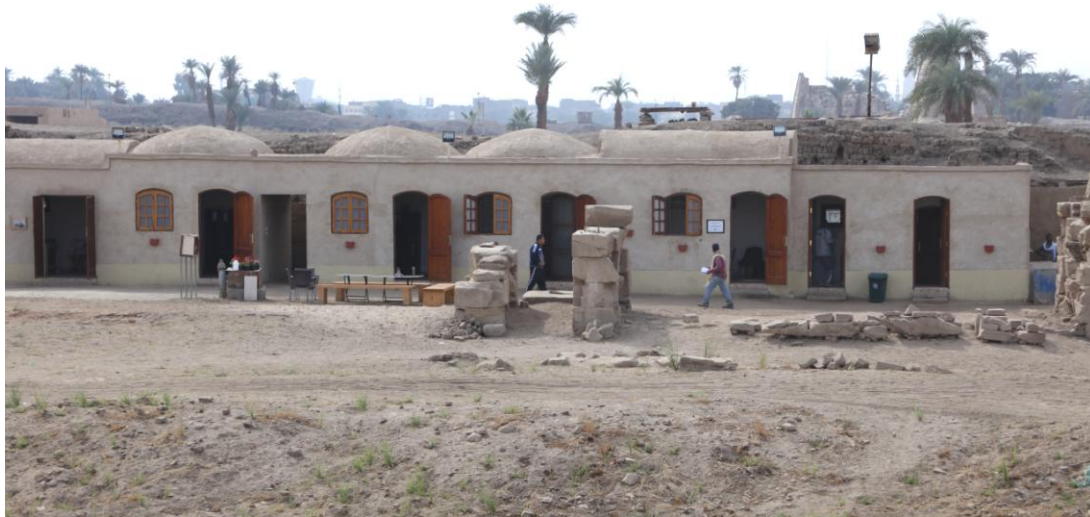
Fig. 15 New offices and storerooms on the site © MTP

Instead of the previous offices built between the gates opened on the southern enclosure wall, a series of the new offices have been set up under the foot of the northern wall of the grand Amun temple, including the meeting room, the laboratory, the storeroom, the offices for inspectors and team members and other annexes. All the rooms are equipped and the laboratory could be used for ceramic studies and also some restoration works. The improvement of the site of the Montu temple is a sort of continuous work which depends on the necessity in the future.

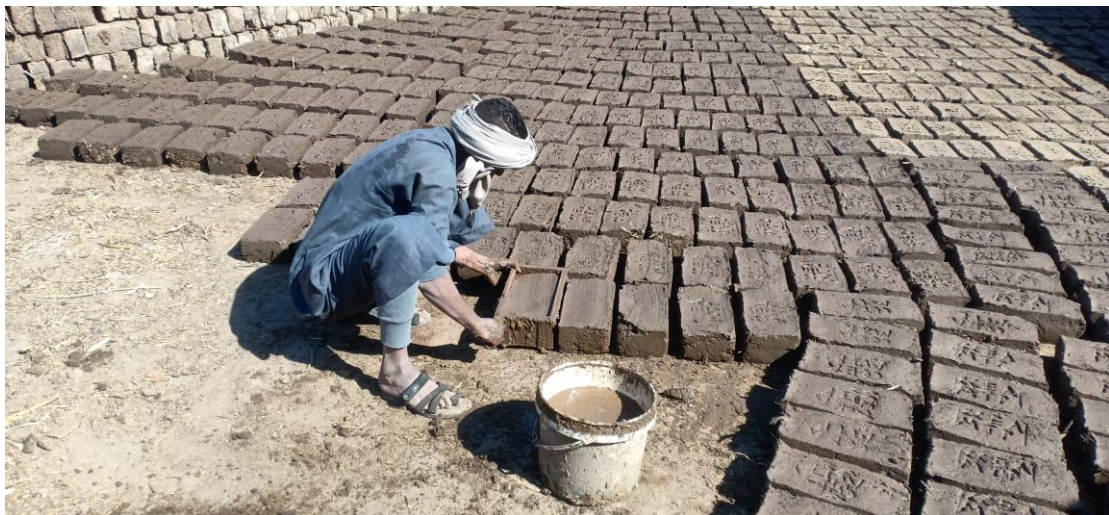
Fig. 16 Processes of making Mud-bricks © MTP

The mission also took advantage of the nature of the site and recycled the rubble resulting from excavation work, and re-used it in making mud bricks, which can be used in the work of rebuilding mud buildings, such as fences, walls, and mud-brick foundations, in addition to using them to cover and protect the excavation sites after the end of the season.
