# Architectural Complex VI of Changle Palace, Han Chang'an City in Xi'an

**Han Chang'an Archaeological Team, Institute of Archaeology, Chinese Academy of Social Sciences**

From November 2005 to January 2006, Han Chang'an Archaeological Team of the Institute of Archaeology, Chinese Academy of Social Sciences excavated the northern periphery of Architectural Complex VI located in the northwest of Changle Palace site. The primary result was bringing to light a pair of auxiliary compounds on the east and west wings of the main hall of Complex VI. The auxiliary compounds comprised of structures of halls, verandas, rain aprons and open-air courtyards. The hall structures were indicated by raised rammed-earth foundations, rows of stone pillar bases on the perimeter, and a set of semi-subterranean features in the west compound. The floors of the verandas were lined with square bricks, flanked by rows of stone pillar bases with occasional traces of wooden pillars. The rain aprons were paved with pebbles and rectangular bricks. The courtyards featured water systems comprised of wells, saturation pools, pipelines, runoff ditches and drainage. The assemblage of material remains comprised mai

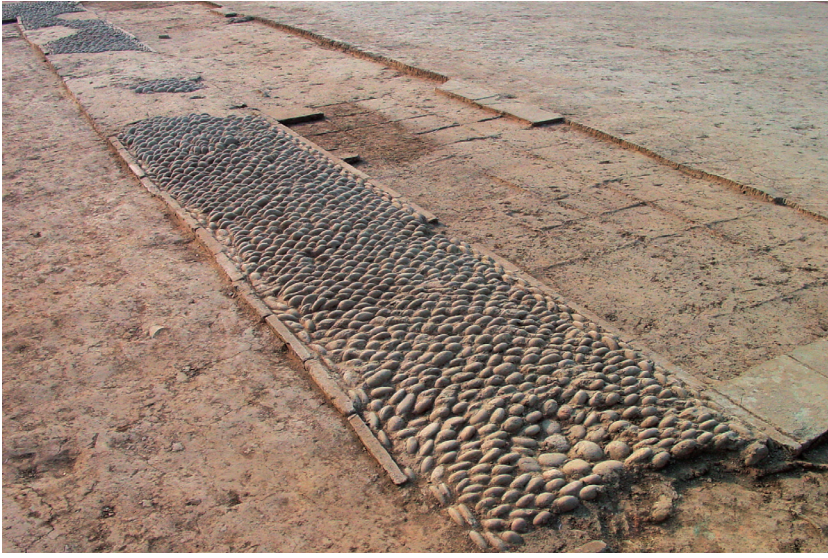
**Figure 5** Rain apron and veranda foundation in the east side of auxiliary compound I (NE-SW).

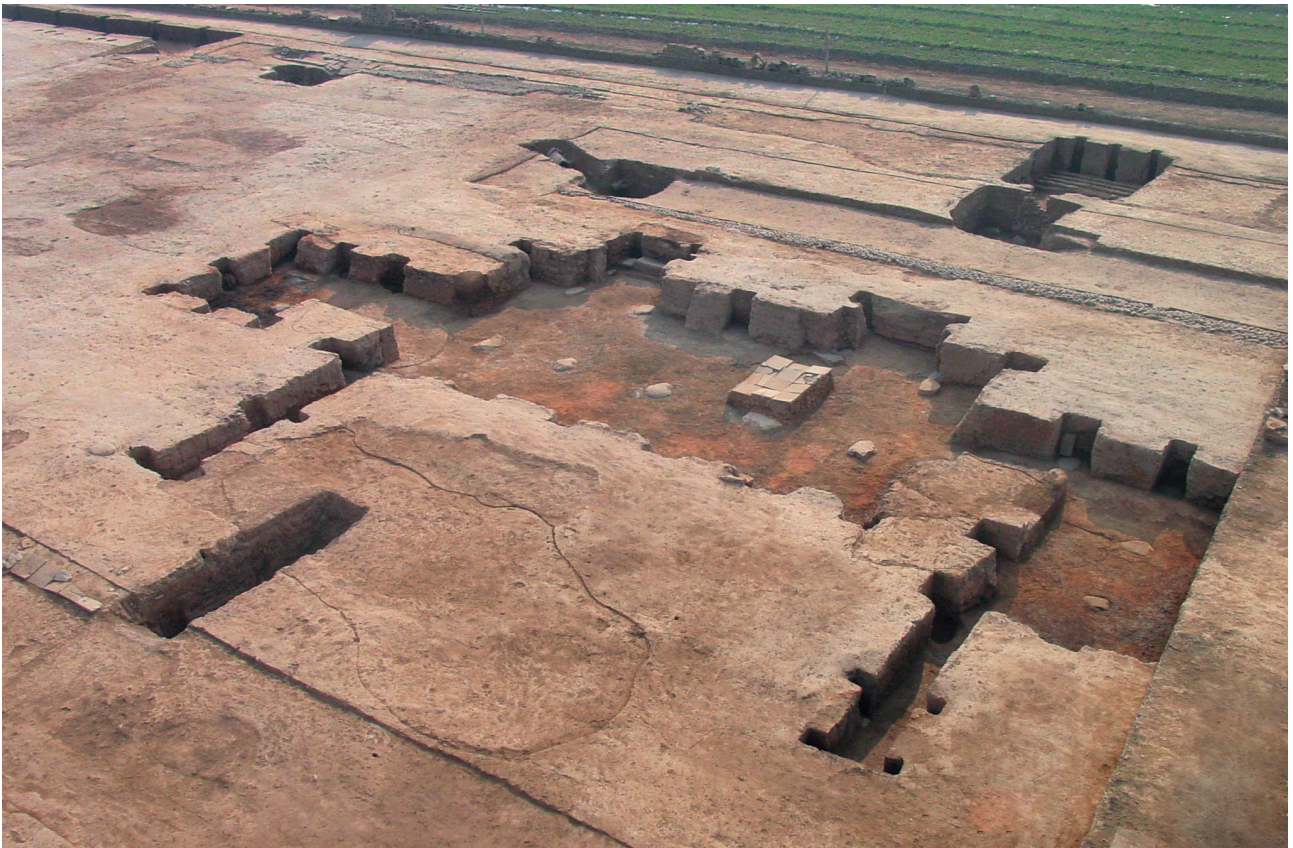
Feature F1 was located in the western part of auxiliary compound II. Since the western half of F1 situated outside of the excavation zone, it had not been fully revealed. The feature was a two-storied structure. Its upper story had been completely destroyed. Its lower story was a semi-subterranean structure comprising of a main room and two side rooms in the east and the west. The excavated

portion of the structure measured 18.6m long and 11.29m wide. The remaining walls were 0.53–0.73m high (Figure 6). The main room measured 9.5m and 5.43m, and its remaining walls were 0.45–0.73m high. The subsurface level of the main room featured a space shored by a pillar network. Pillars were also engaged in the walls and corners, and five pillar bases were found on the internal floor. Two rectangular doorways opened on the south wall. A hollowed brick was placed in the east doorway, functioned as a stepping stone. A vent opened on the north wall. Its leveled earthen floor was rammed and baked to reddish-brown. The floor of the upper structure was paved with square bricks. It was destroyed by fire and the ruins collapsed onto the floor of the lower structure. To the west of the main room was the west side room. Its rectangular plan measured 2.07m long and 0.71m wide. A vent was opened on the north wall. The rectangular east side room measured 2.92m long and 2.8m wide and a remaining height at 0.53–0.66m. It had a network of pillars similar to that of the main room. In between the east side room and main room was the east corridor. Its rectangular plan measured 2.69m long and 2.84m wide.

**Figure 6** Structure F1 (NW–SE).

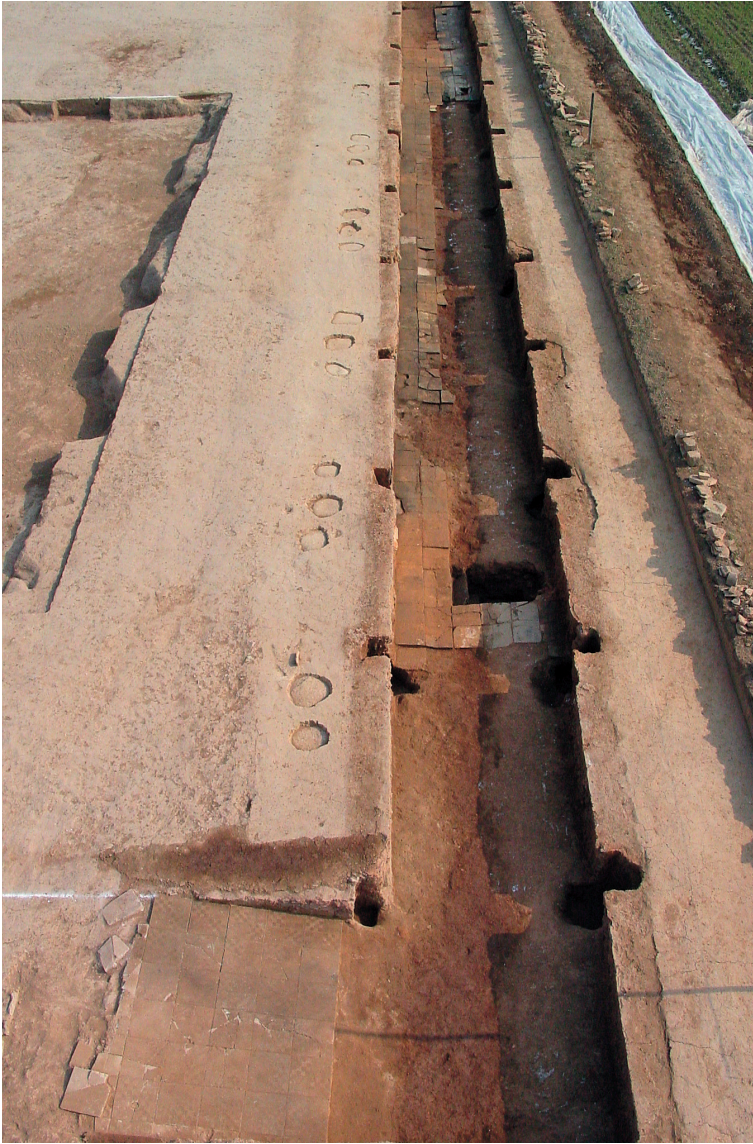
Subsurface passage I situated between the main hall and auxiliary compound I. It was a semi-subterranean passage leading into the auxiliary compound. The floor of the passage was lower than the foundations of the structures flanking it, making it a semi-subterranean L-shaped cov-

ered passageway. The walls of the passage were shored by pilasters. The passage comprised of a main leveled passage and two ramps. The whole feature was 34.29m long and 4.93m wide (Figure 7). The main passage measured 32.19m long and 1.84–1.91m wide. Both the north and south walls were reasonably well preserved. Their remaining heights were 0.53–0.6m. The rammed walls were coated with two to three layers of daub and plastered with one layer of white lime solution. Each of the north and the south walls had eleven pilasters, mirrored to each other. Several granite pillar bases had been recovered. The floor of the main passage was lined with six rows of square bricks. Underneath the main passage laid the pipeline made of two rows of pentagonal pottery pipes described above. The east ramp measured 2.18m long and 1.52–1.62m wide. It had a brick-paved floor and a trough with wood ashes on its western end, indicating the setting of a wooden door. The west ramp measured 3.12m long and 2.12m wide. Its floor was paved with seven rows of square bricks decorated with geometrical patterns on one side, with the patterned side faced up (Figure 8).

Figure 7 Subsurface passage I (W-E).

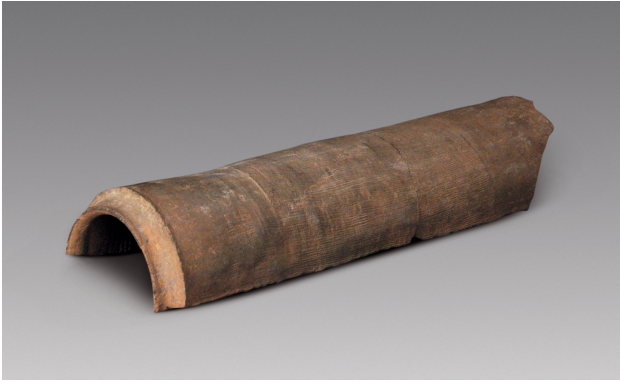
Semi-cylindrical tiles. T3 ② :9, short lip, thin and light body, built with coiling method. The cut marks on the paste indicated that it was cut by exterior-cut method out of the original cylindrical paste. Its upside was embellished with fine cord marks; wherein its underside was embellished with dot pattern. The tile measured 53.4cm long and 15.8–16.8cm wide (Figure 9). T1 ③ :55, long lip, thick and heavy body. It was embellished with medium or coarse cord marks on the upside, and textile print on the underside. The artifact measured 57cm long and 8.5–8.8cm wide (Figure 10).

Figure 9 Semi-cylindrical roof tile Type A (T3 ② :9).

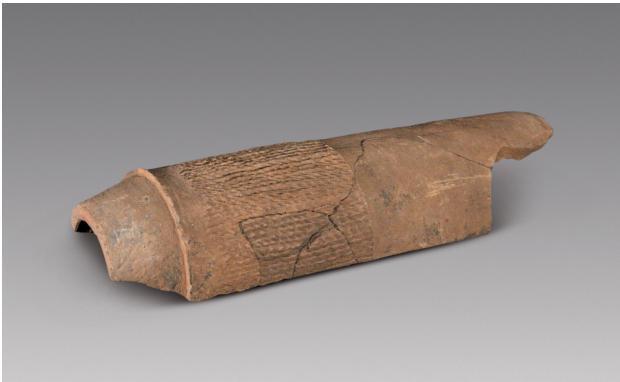
Figure 10 Semi-cylindrical roof tile of Type BI (T1 ③ :55).

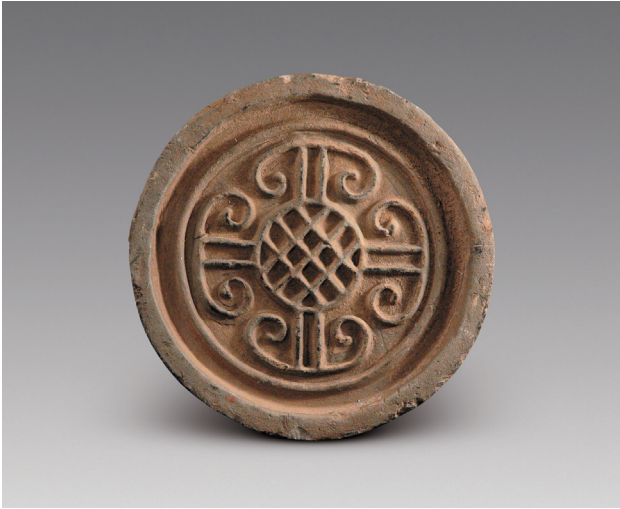
Figure 12 Cloud-patterned tile-end (T3 ② :1).

Cloud-patterned tile-ends. Some of the cloud-patterned tile-ends were made together with semi-cylindrical tiles in one process. They showed cut marks on the backs of the ends. The end face had a circular ridge on the periphery and four evenly distributed double borderlines that did not cut into the center. The centers were embellished with patterns of oblique checker, Union Jack, persimmon calyx (quatrefoil), and nipples. T3 ② :1 was a semi-cylindrical tile embellished with hand-smoothed cord marks and the stamp with characters “*dajiang* 大匠” on the upside. It measured 17.9cm in diameter (Figure 12). Some tile-ends were independently made and attached to the semi-cylindrical tiles to assemble. This type of tile-ends did not have cut mark at their backs. The end faces were embellished with one round of ridge on the periphery and double-lined cross that joined the ridge and cut into the center, partitioning the end faces into four sectors, each embellished with one cloud pattern. The circular center was embellished with one big triangle. Specimen T1 ③ :12 was embellished with cord mark on the upside and textile print on the underside. Its face measured 18.1cm in diameter (Figure 13). Some ends had nipple pattern in the center; whilst some had the nipple pattern encircled by one ring of bead

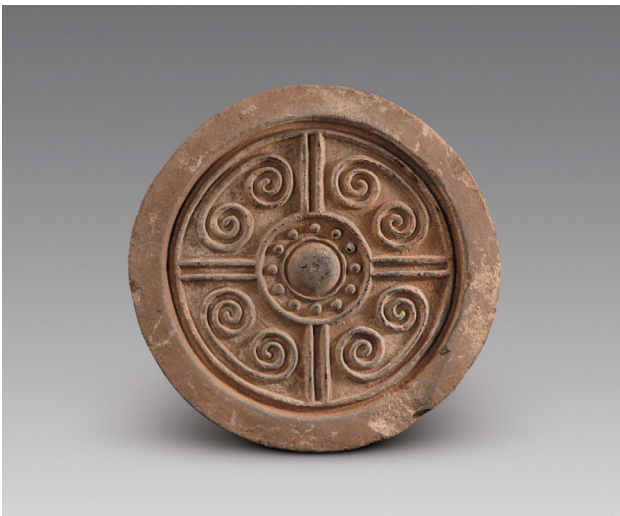
Figure 14 Cloud-patterned tile-end (T6 ② :1).

pattern. T6 ② :1 measured 19.5cm in diameter (Figure 14).

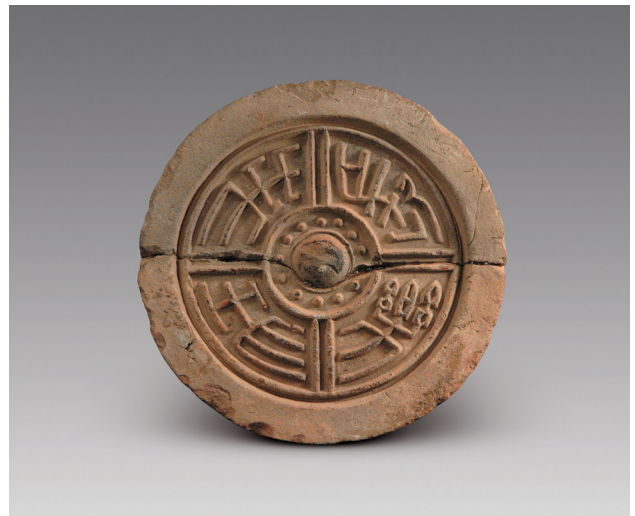
Figure 15 Tile-end with “Changle weiyang” inscription (T1 ③ :10).

The majority of the scripted tile-end assemblage was that of the “*Changle weiyang* 长乐未央” style. One round of ridge embellished the periphery of the ends. It was then followed by double partitioning lines that did not cut into the center. The centers were embellished with one large stereoscopic nipple, two rounds of ridges and 12 to 16 small nipples in between the ridges. The scripts of “*chang* 长”, “*le* 乐”, “*wei* 未” and “*yang* 央” in seal style distributed on the four partitioned sectors of the end face. T1 ③ :10 measured 18.8cm (Figure 15).

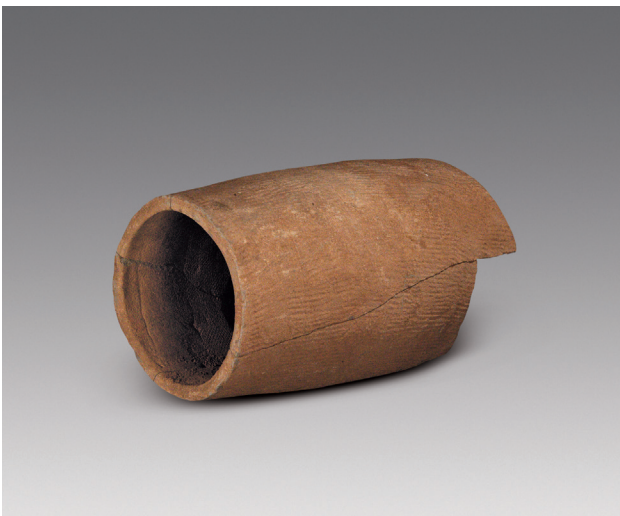
The pottery pipes had round and pentagonal types. T6 ③ :8 was a round pipe with a diameter of 23cm and the remaining length measured 46.5cm (Figure 16). The center of the pipe was thicker than the ends. Its outside was embellished with coarse cord marks; wherein its inside was embellished with dot pattern. T6 ② :5 was a section of pentagonal pottery pipe that measured 39cm in

Figure 16 Circular pottery pipe section (T6 ③ :8).

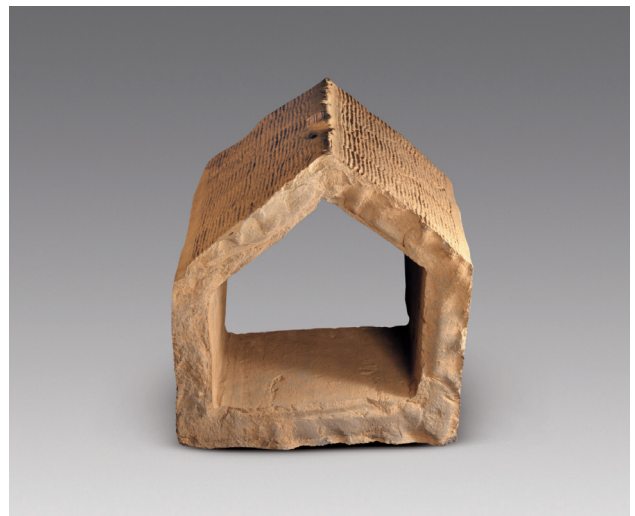
remaining length and 41cm high. Its outside was embellished with coarse cord marks (Figure 17).

Figure 17 Pentagonal pottery pipe section (T6 ② :5).

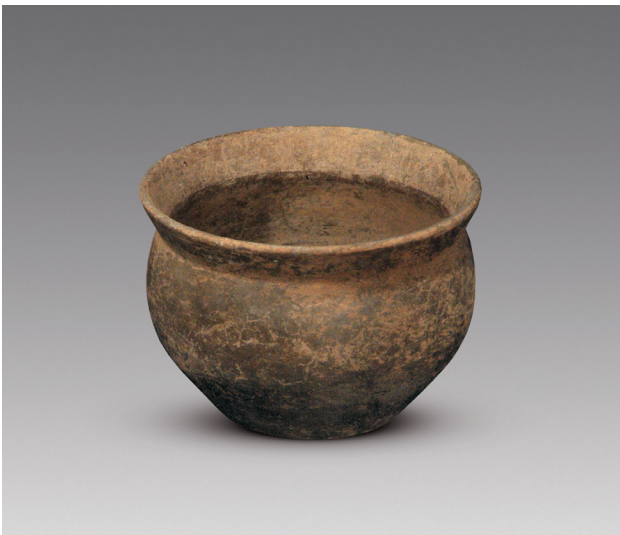
**Figure 19** Small pottery jar (T4 ③ :18).

quantity of domestic pottery of basins, bowls, small jars (T4 ③ :18, Figure 19), small pots, lamps (T1 ③ :82, Figure 20), vessel lids, spindle whorls, and pellets, and small quantity of iron artifacts of nails, rings and knives, and bronze artifacts of architectural components, arrowheads, cloud-patterned fittings, mirrors, armor elements, and disc-shaped plates, etc.
