New Archaeological Discoveries South of the Hanyuan Hall at the Daming Palace of Tang Dynasty

The Xi'an Tang City Archaeology Team, IA, CASS

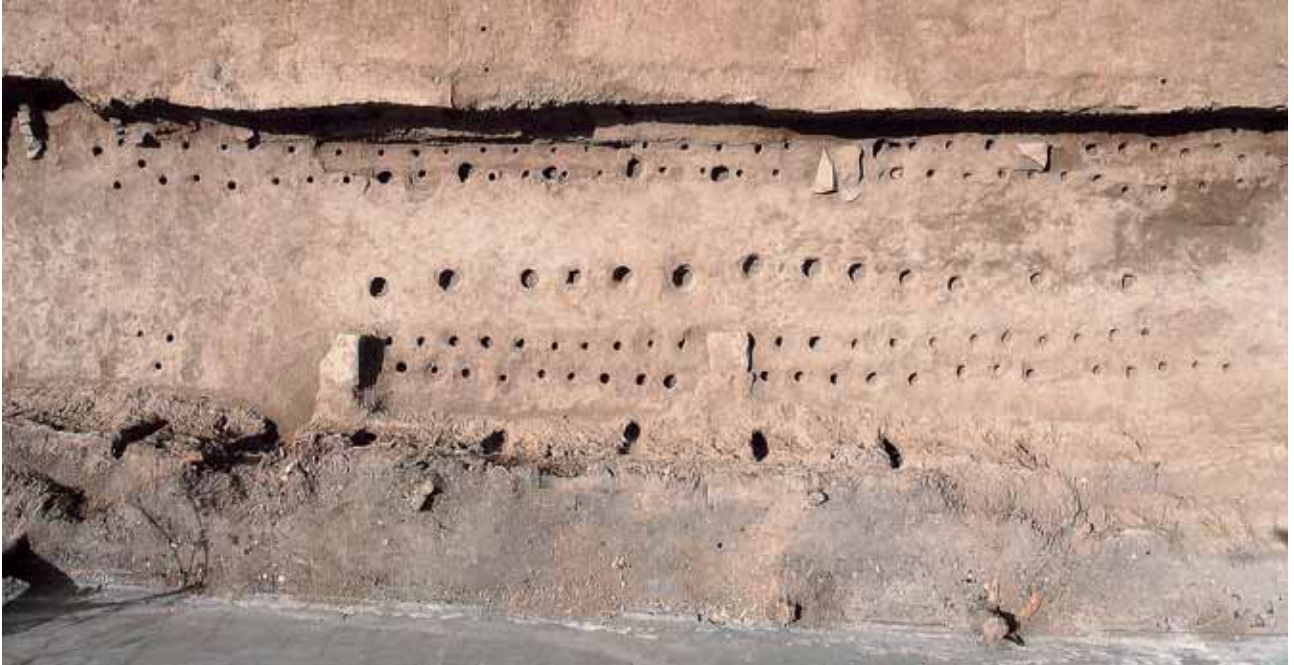
It faces north toward the center of the Hanyuan Hall. Remaining holes of bridge piers indicate that the bridge runs 17m west to east in width, and 4.3m north to south in length. The seven rows of piers can be divided into three sections (Figure 1).

The northern section has three rows of piers. The northernmost row is built tightly against canal wall. Intervals between the piers are relatively wide, and the holes are quite large, measuring from 20 to 28cm in diameter. The other two rows were built south the northernmost row, with smaller piers very close to each other. The diameters of the holes for these piers are between 12 and 16cm. Two rectangular shaped foundation rocks were found between these two rows.

The middle section has only one row of piers, located in the center of the canal. The holes for these piers are quite large, measuring from 22 to 40cm in diameter.

The southern section has also three rows of piers, arranged the same way as those in the northern section. The row next to the canal wall has only four pier holes left, measuring from 11 to 16cm in diameter. The holes for the piers in the two rows next to southernmost row measure from 7 to 25cm in diameter.

Figure 1. The Central Bridge across the Canal to the South of Hanyuan Hall (Top. South)

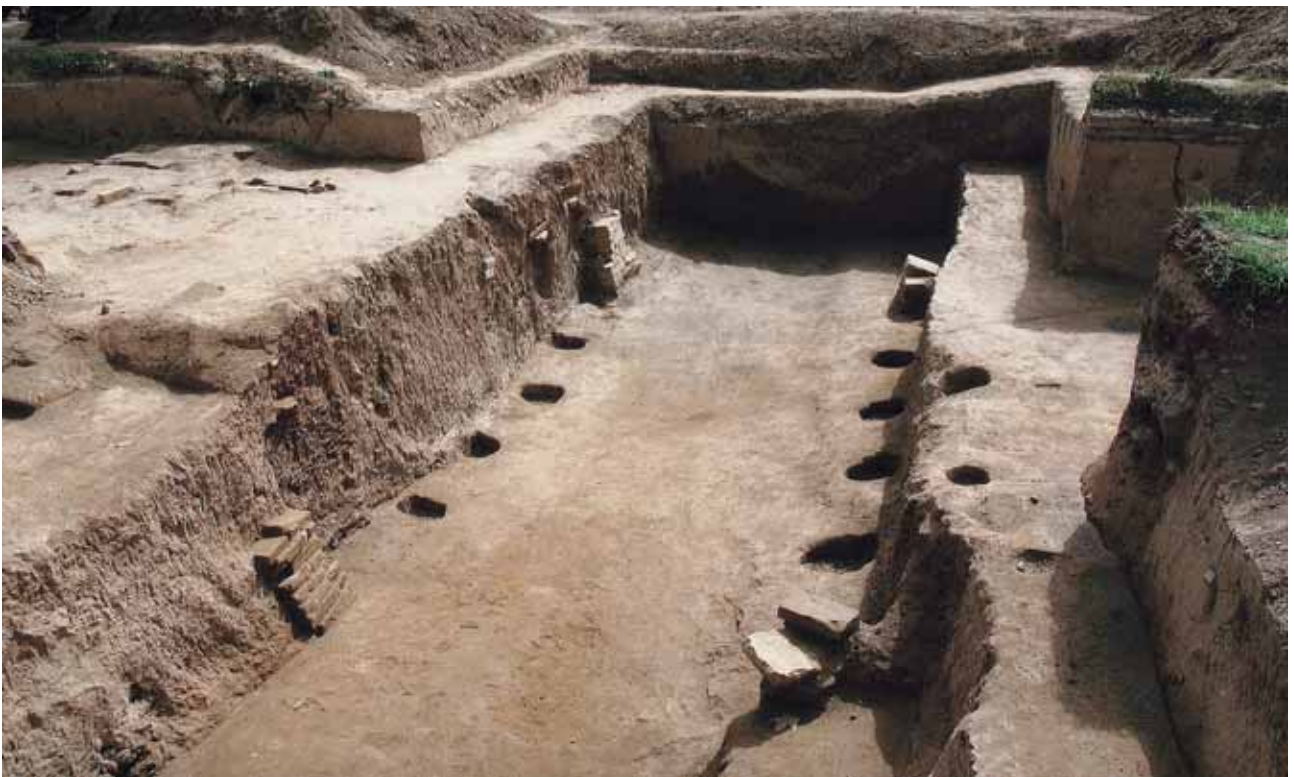
The west bridge faces the Western Audience Chamber of the Hanyuan Hall. The bridge is located 128m west of the Central Bridge. Remains of brick piers and pier holes were found, measuring 6.85m from west to east in width, and 4.65m from north to south in length. Four brick piers were built next to the canal walls, two on each side, opposite each other. The two brick piers found next to the north bank are 5.48m apart, and the

remains of the two piers are 0.73 and 1.45m in height. The two next to the south bank are 5.5m apart, with a remaining height of 0.4 and 0.45m respectively. A single row of piers stood on both sides of the bank,

with remaining holes are from 28 to 45cm in diameter (Figure 2).

Figure 2. The West Bridge to the South of the Western Audience Chamber of Hanyuan Hall (West-East)

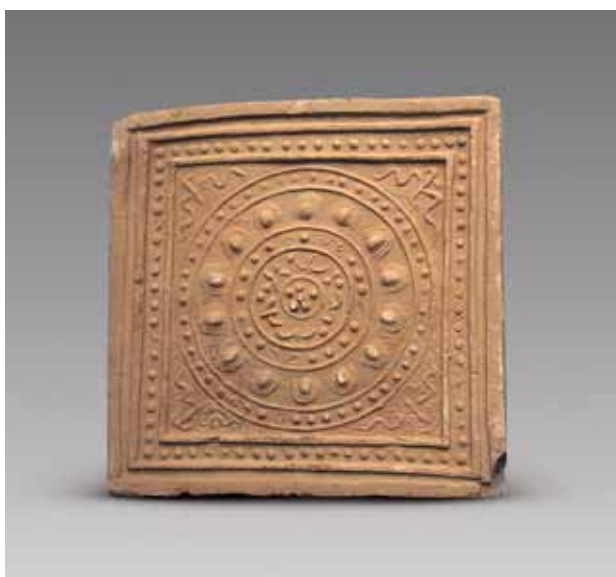
Figure 3. Square Paving Brick with Lotus Motif (2006TCDYQ1 :2)

In the canal, we found various Tang artifacts, including bricks, tiles, rocks, shells, ceramic and porcelain objects, coins, iron nails, and an iron sword. The most numerous were bricks and tiles, including rectangular shaped bricks, plain square bricks, patterned square bricks, flat roof tiles, and eave-tiles with a lotus motif. Some bricks have carved characters. Two inscriptions have been read as “ Official Brick (*guan-zhuan* 官砖), ” and “ Kai [yuan] period, ninth [year], sixth month (721 CE), Official Brick ” (Figures 3–6).

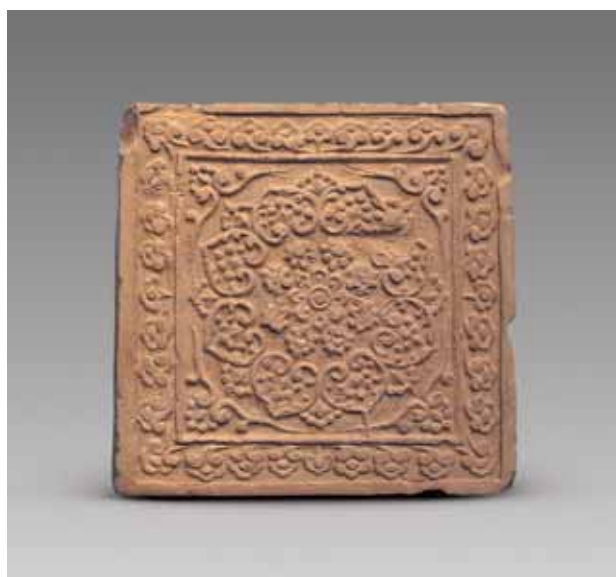
Figure 4. Square Paving Brick with Rosette Motif (2006TCDYQ1 :3)

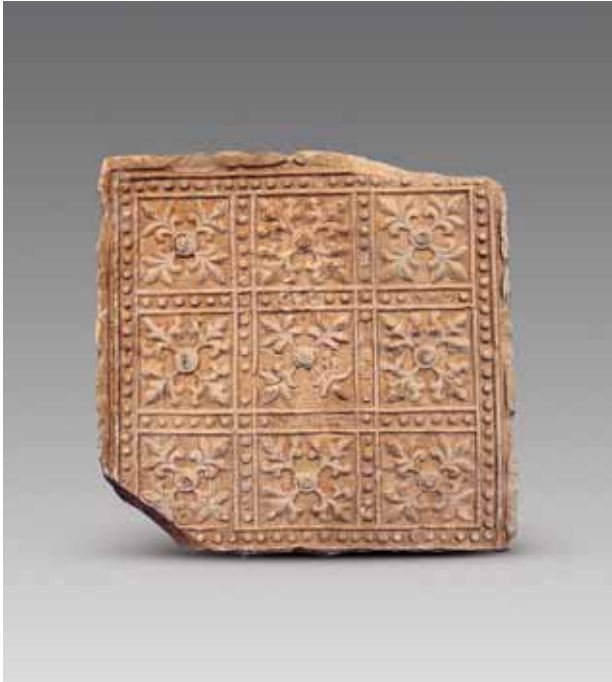
Figure 5. Square Paving Brick with Honeysuckle Motif (2006TCDYQ1 :4)

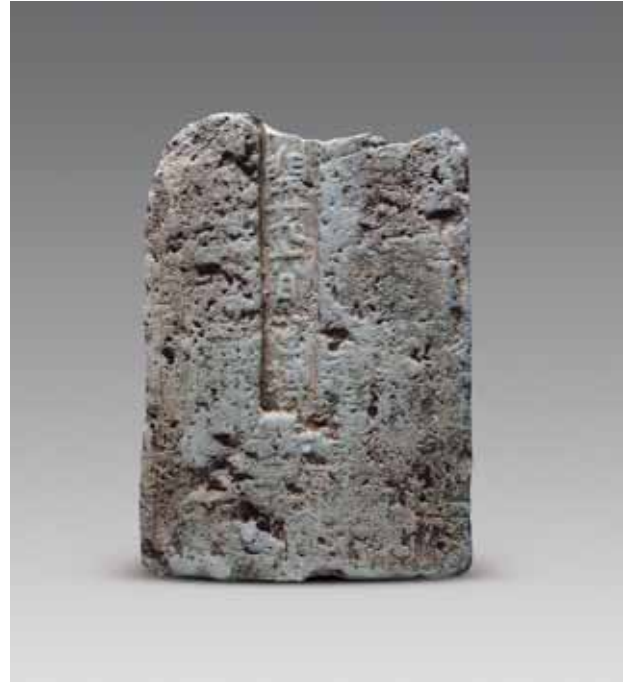
Figure 6. Inscribed Brick unearthed from the Canal to the South of Hanyuan Hall (2006TCDYQ1 :10)
